Assessment of Existing Masonry Resistance Using Partial Factors Approaches and Field Measurements

Source / Izvornik: **Buildings**, 2023, 13, 1 - 16

Journal article, Published version

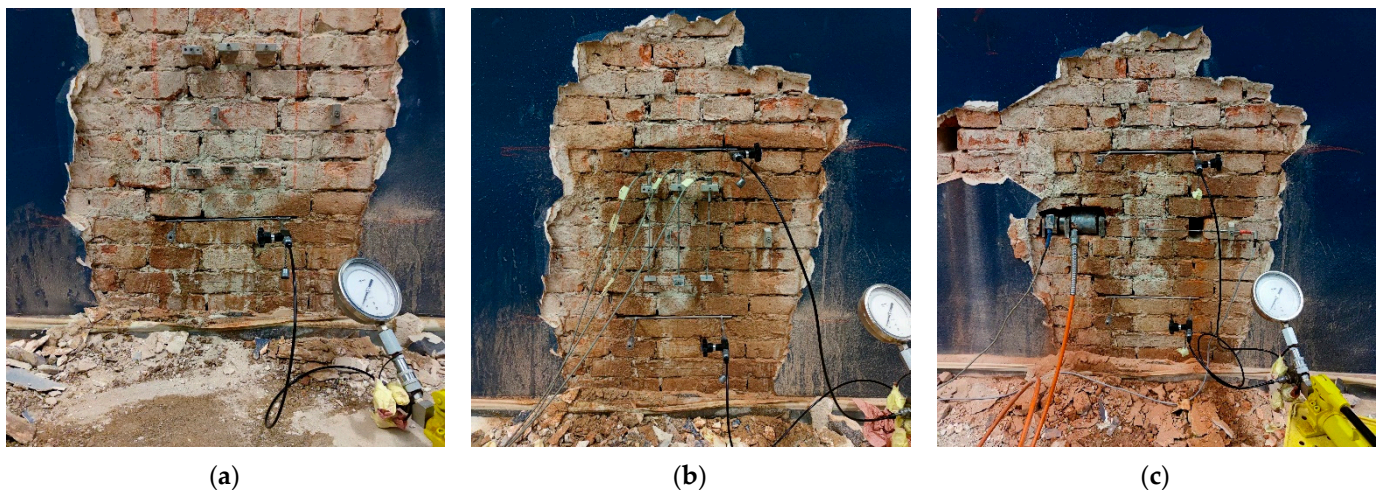
Given that the mechanical properties of existing masonry structures can vary greatly, it is very useful to determine the actual values of these properties through in situ testing [52]. As part of the investigative work, flat-jack tests were performed on three original load-bearing walls from the same construction period that have a similar thickness. The locations of the tests are marked with red triangles in Figure 2b. All phases of the test itself are shown in Figure 3.

Figure 3. Flat-jack test setup for determining (a) vertical stress state, (b) modulus of elasticity and (c) shear strength.

Using only conservative values of the material mechanical properties, without in situ tests, can result in a significant overestimation or underestimation of the structural capacity. In situ, semi-destructive methods such as flat-jack can significantly contribute to the quality of the assessment procedure. It provides values for the state of vertical stress, modulus of elasticity and shear strength of the masonry. The flat-jack test is not the main focus of this paper and, therefore, will not be explained in detail. For more specific information about the test itself and its application, see [53,54].

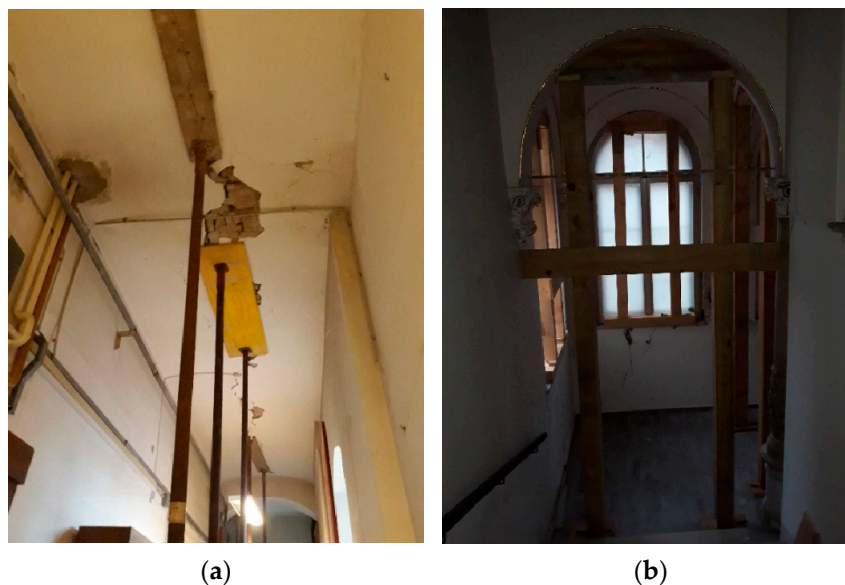
strengthen the structure to current standards. With this in mind, emergency measures are taken throughout the building to ensure the safety of workers as well as the stability of the damaged vaults and staircases. The application of the mentioned measures can be seen in Figure 4.

Figure 4. Emergency interventions taken to ensure the stability of (a) damaged vaults and (b) staircases.

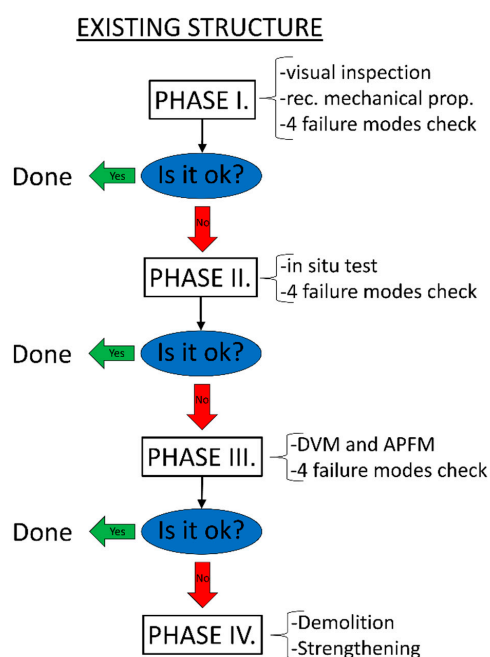
The verification of the selected masonry wall is carried out in three phases. The schematic representation of phases shown in Figure 5 is an adaptation according to [47]. The dominant mode of failure, that is, the mode with the least resistance is most often diagonal failure, but all four failure modes should be checked for every wall because the typology of the wall, the boundary conditions and the distribution of internal forces can affect the dominant failure mode.

Figure 5. Assessment phases.

Initially, data combining recommendations from standards and assumptions are used (phase 1). Then, the data obtained by flat-jack testing are used to update previously used data (phase 2). And finally, DVM and APFM analysis is conducted (phase 3). Phases 1 and 2 are conducted through a semi-probabilistic approach defined in Eurocode.
