# Non-Destructive Corrosion Inspection of Reinforced Concrete Using Ground-Penetrating Radar: A Review

Tešić, Ksenija; Baričević, Ana; Serdar, Marijana

Source / Izvornik: **Materials**, 2021, 14, 1 - 20

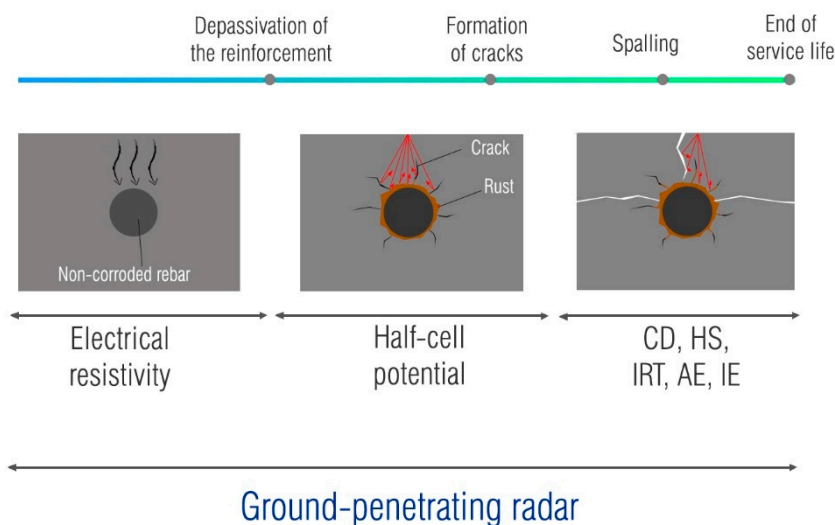
The previous section has shown that corrosion assessment in on-site corrosion testing is mostly based on the assessment of the attenuated areas identified by signal amplitude analysis. Most of the studies are carried out on the bridge decks. In terms of comparison with other NDT, GPR has been compared with various techniques used for the service life condition assessment of the structures, Figure 5.

**Figure 5.** Multiple NDT used for the condition assessment.
