# Non-Destructive Corrosion Inspection of Reinforced Concrete Using Ground-Penetrating Radar: A Review

Source / Izvornik: **Materials**, 2021, 14, 1 - 20

**Keywords:** ground-penetrating radar (GPR); non-destructive techniques (NDT); corrosion of reinforcement

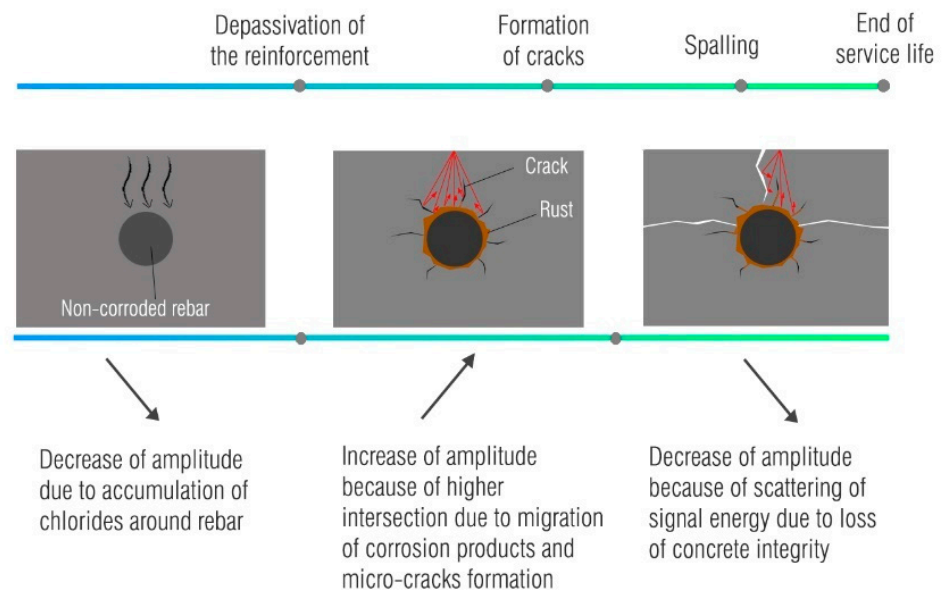
The corrosion process can be divided into the initiation and propagation phases, with each phase having specific effects on concrete microstructures. From the long-term corrosion monitoring experiments, the influence of corrosion promotion on GPR attributes was summarized, as in Figure 3.

**Figure 3.** Changes in the GPR signal during corrosion process.

The effects shown in Figure 3 are determined by the accelerated corrosion processes, in particular the formation of corrosion products on the surface of the reinforcing bar, their diffusion into the concrete cover and thus, crack propagation. These effects modify the amplitude in terms of different reflection coefficient and different dielectric properties of the concrete cover. The ability of corrosion products to migrate depends on the moisture content in the concrete cover since their movement is favored in the presence of moisture [59]. Similarly, the ability of their migration depends on the duration of the acceleration process. When accelerated corrosion with high current density is established in a short timeframe, it leads to increased crack width due to the sudden accumulation of corrosion products and increased pressure around the reinforcement [50,60]. Therefore, an appropriate current density should be selected to ensure the best possible simulation of natural conditions still within a reasonable timeframe [50,61].

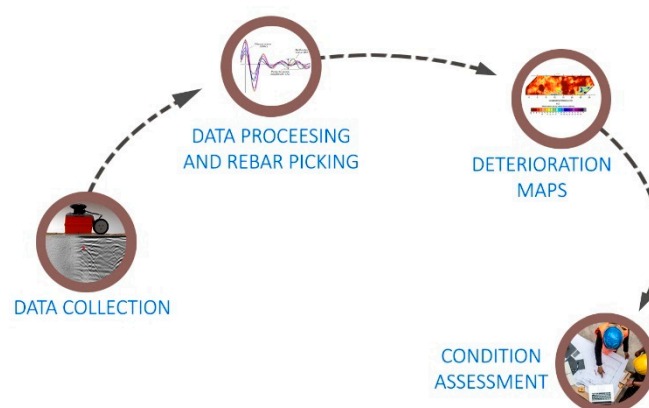
Numerical analysis is generally used to obtain the deterioration map, which in most cases is the spatial distribution of normalized amplitudes. The main steps of the numerical approach in the condition assessment of concrete bridge decks are shown in Figure 4. The ability of the numerical approach to provide autonomous assessment of concrete structures using GPR is one of the reasons for its predominant use, while the algorithms for automatic reinforcement selection can be found in References [79,80].

**Figure 4.** Numerical approach in condition assessment of concrete bridge decks.
