# Influence of train type and rail surface roughness on railway traffic noise

**Lakušić, Stjepan; Bogut, Marijan; Haladin, Ivo**

*Source / Izvornik:* **Mehanika. Transport. Komunikacii, 2011, 3**

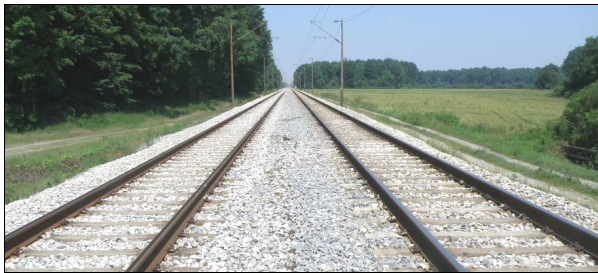
**Figure 1** Railway line M105 (Vrpolje – Ivankovo)

In this case measurements have been conducted on 100 m long sections of two railway lines M104 (section Vrpolje – Ivankovo) and M105 (section Velika Gorica – Sisak), Figures 1&2. These sections have been selected based on the geometrical elements that allow testing the trains at a maximum speed. The results of a measuring train (received from HŽ Infrastructure) have also been analyzed.

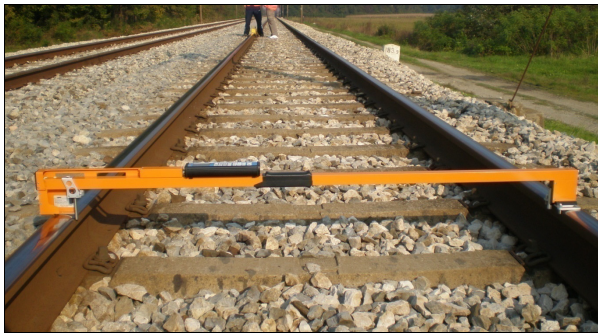
**Figure 3** Manula track geometry measurement

In frame of permanent way validation on the described sections, the control of geometry (track gauge, cant, weld and isolated joint state and position, Figure 3) and rail head roughness (Figure 4). Both measured sections have met the required geometry standards according to the Croatian standards for railway track maintenance [4], [10].

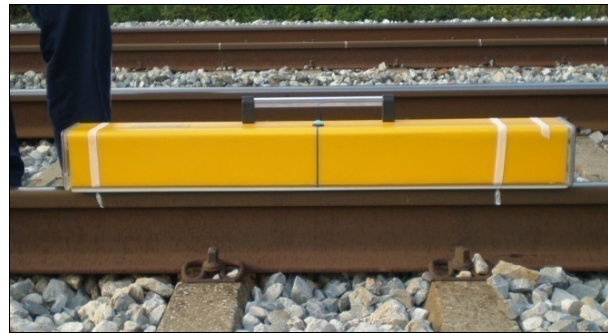
**Figure 4** Rail surface roughness measurement

Since measurements of rail roughness have been conducted with 1 m long measuring device, wavelengths up to 0,1 m. According to EN ISO 3095:2007 both sections have been evaluated as suitable for typical noise measurements in terms of rail roughness. As described in Figure 5 and 6, both the whole analyzed spectrum of both railway lines fits in the tolerant range according to the standard, hence the sections have been positively evaluated.

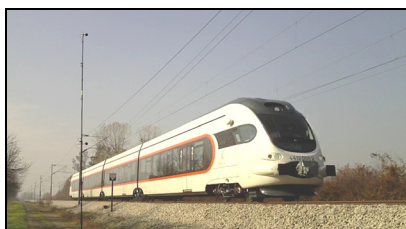
**Figure 8** EMV ŽFBH 4412

Results of the measured A-valued equivalent continuous noise levels for an new electric commuter train - EMV (made by Koncar Electric Vehicles), a standard passenger train (electric locomotive 1141 and 4 wagons) and freight train (electric locomotive 1141 and 24 freight wagons) are shown in the Table II. EMV noise has been recorded at running speed of 80, 120 and 160 km/h, while passenger and freight trains have been recorded at standard running speed of 120 and 80 km/h according to the train timetable.

In accordance with the method of determining environmental noise levels of railway vehicles according to TSI-Noise directive results of measurements of microphone at stand A, height 1,2 m, have been standardised to the referent speed of 80 km/h (correction of -5,3 dB @ 120 km/h and -9,0 dB @ 160 km/h). Noise levels for different train types are as follows: EMV 80 dB(A), passenger train 87 dB(A) and freight train 94 dB(A) (Figures 8, 9 and 10). Noise levels of new EMV are 7 dB(A) lower compared to a standard passenger train and even 14 dB(A) lower than a freight train.
