Influence of Horizontal and Vertical Barriers on Fire Development for Ventilated Facades

Čolić, Antonela; Banjad Pečur, Ivana

Source / Izvornik: **Fire Technology**, 2020, 56

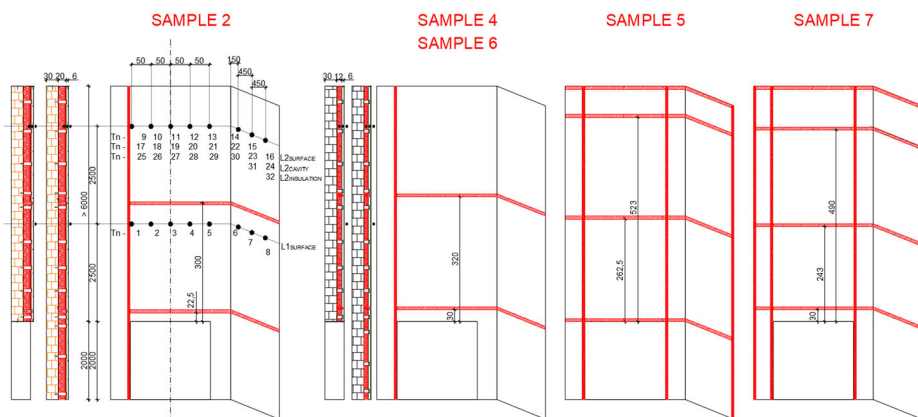
Figure 1. Schematic of test apparatus, position of external and internal (cavity and insulation) thermocouples, horizontal and vertical barriers.

Figures 1 and 3 show the position of the thermocouple relative to the position of the barrier for easier result monitoring. Samples 1 and 3 are not shown because they do not have any horizontal nor vertical barriers. Thermocouples are positioned as follows: Tn-1–Tn-8 are 50 mm from the external panel on level one, Tn-9–Tn-16 are 50 mm from the external panel on level two, Tn-17–Tn-24 at the midpoint of the air cavity layer on level two and Tn-25–Tn-32 at the midpoint of the insulation on level two. To describe a thermocouple position, following abbreviations will be used (Fig. 3).

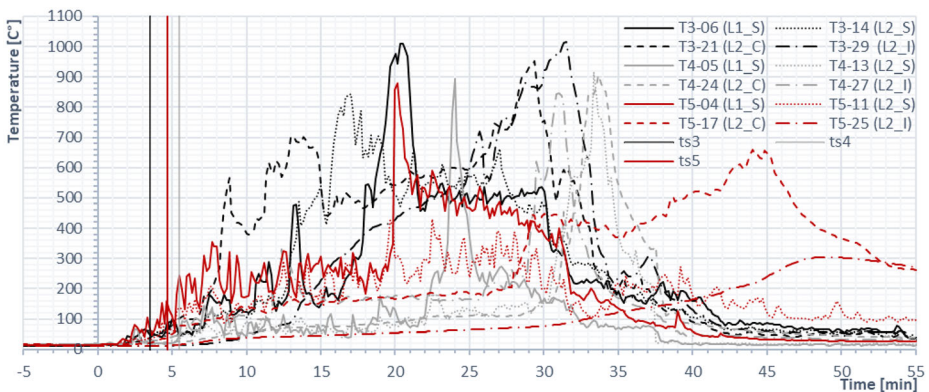
Figure 7. Temperature development in 60 min on thermocouples with Tmax for both levels—Sample 3,4 and 5.

If we observe the maximum temperatures in Fig. 7 at L1_S for all three samples they appear around the centre line of the Sample, on the main wall. Although the peaks (Fig. 7) for all three samples are similar, around 900°C, it seems that the addition of cavity barriers, especially horizontal, delays the time to reach the peak temperature. For Sample 3, there is no horizontal barrier to prevent the early occurrence of T_{max} and heat transfer can increase with larger flame lengths. High temperatures are visible in all layers and the fire spread is assisted by buoyancy which keeps the flame aligned with combustible insulation [31]. This way, upward flame in combination with narrow cavity ensures the effective heat transfer by convection towards the combustible insulation that has not ignited yet. The horizontal barrier is located 30 cm above the chamber for Sample 4 while Sample 5 has a barrier right at the top of the chamber. The importance of this position can be described with t_s ($t_{s4} = 5:50$, $t_{s5} = 4:40$). The distanced barrier delayed the beginning of standard testing, and the temperatures higher than 200°C at L1_S was reached one minute later. Furthermore, for Sample 4, the delay to reach maximum temperatures in all layers in relation to Sample 5 is apparent.

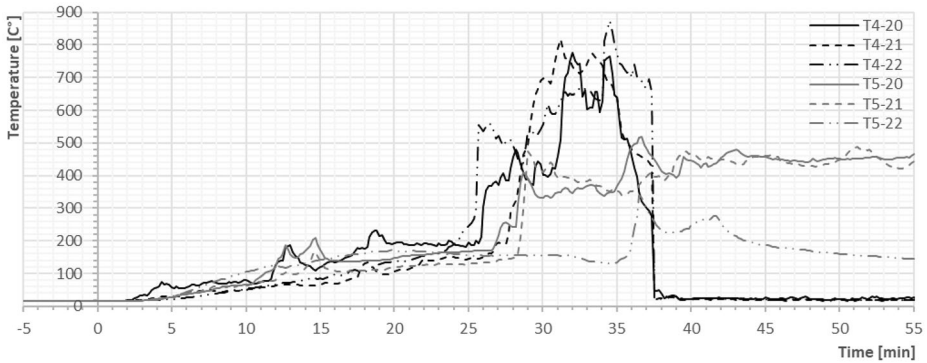
Figure 9. Temperature of thermocouple Tn-20-21-22 in cavity for Samples 4 and 5.

The beneficial effect of a vertical barrier could be seen in Fig. 9 with the graphs of developed temperature on thermocouples in L2_C. Tn-21 is the rightmost thermocouple located on the main wall in L2_C. In relation to Tn-21, Tn-20 is on his left side (main wall) and Tn-22 on the right side (wing wall). For Sample 4, fire curve peaked with 775.6°C on the main wall with almost repeated temperature value with the delay of 3 min on the wing wall. For Sample 5, where the vertical barrier was used on the right side of the chamber, the maximum temperature on the left side of barrier (T5-20) was almost two times higher than the temperature developed on the right side of the barrier (T5-22 on the wing wall). The vertical barrier effectively prevented further horizontal spread of fire by cavity layer maintaining the temperature on the main wall until the end of the test, while for Sam-

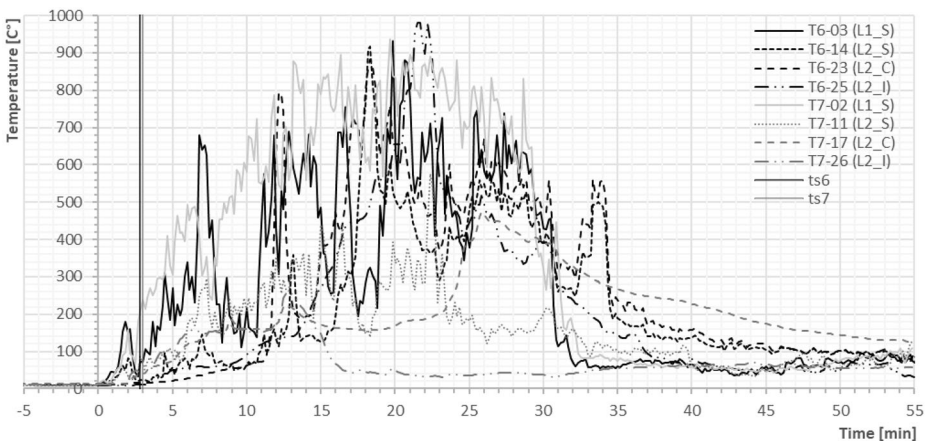
Figure 10. Temperature development in 60 min on thermocouples with Tmax for both levels—Sample 6 and 7.

Difference in temperatures at level 2 for samples with different number of barriers can be seen in Fig. 10. The effect of placing the third and fourth horizontal barrier is similar to the ones of the second set of Samples (Sample 4 and 5). The

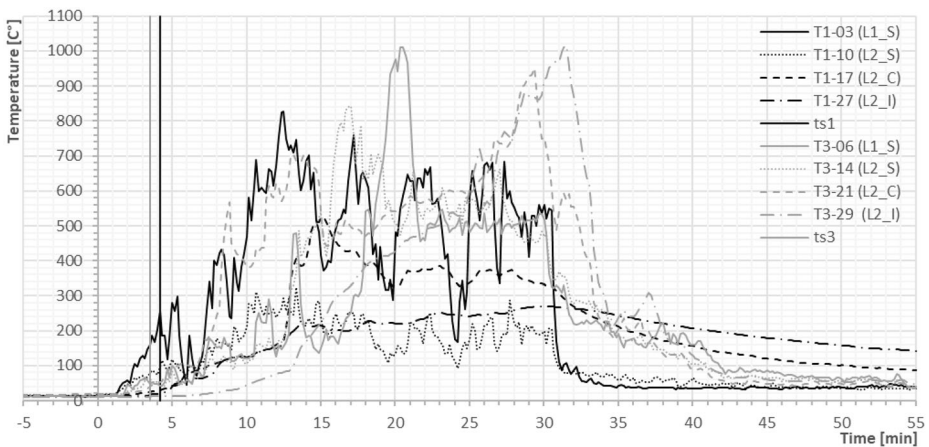
Figure 13. Sample 1 and 3_Non-comustible and combustible insulation_No barriers_Tmax thermocouples.

However, non-combustible stone wool insulation accumulated part of the energy from the fire and therefore surrounding layers were heated up slower. Meanwhile, in Sample 3, combustible polyisocyanurate insulation ignited and contributed to the rise of the temperature in all layers. The highest difference temperatures occurred is in the insulation layer— $\Delta T = 746^\circ\text{C}$. In Sample 3, the insulation completely burned out (shown in Fig. 4).

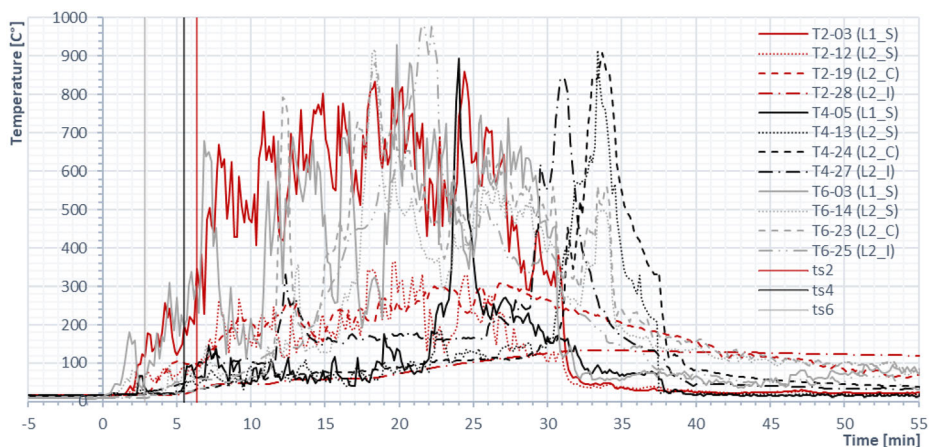
Figure 14. Sample 2, 4, 6—Non-combustible and combustible insulation with two horizontal barriers and two vertical barriers.

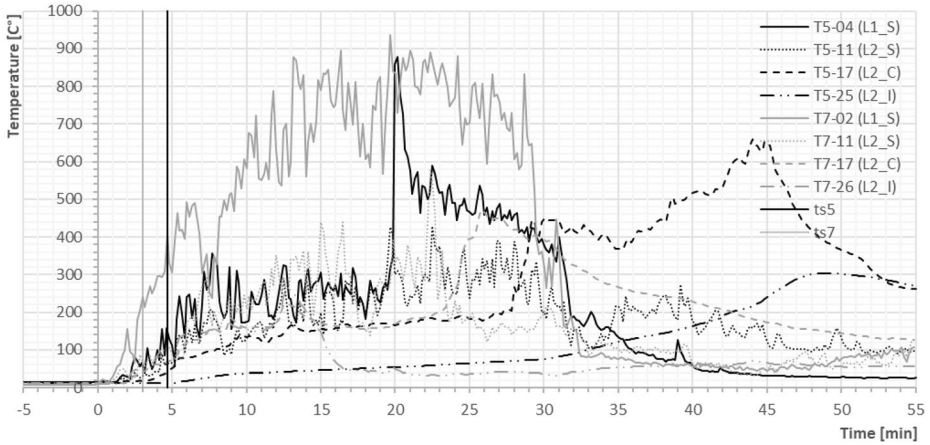
Figure 15. Sample 5, 7 Combustible insulation with four horizontal barriers and three (Sample 5)/four (Sample 7) vertical barriers.
