Influence of Horizontal and Vertical Barriers on Fire Development for Ventilated Facades

Influence of Horizontal and Vertical Barriers on Fire Development for Ventilated Façades

Keywords: Ventilated façade, Cavity barriers, Combustible insulation, Large-scale tests, Fire spread

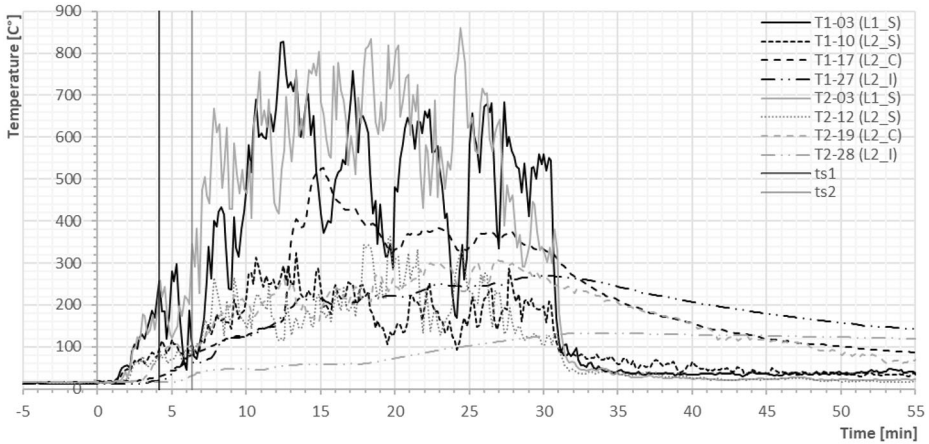
Figure 5. Temperature development in 60 min on thermocouples with Tmax for both levels—Sample 1 and 2.

In following graphs, the thermocouple symbol (Figs. 5, 7, 10) is Tx-n, where x represents the Sample number, and n the thermocouple position where the maximum temperatures (from the moment of heat source ignition) occurred. Since the samples were not examined at the same day and in the identical weather condition, it has no benefit to compare the same thermocouples of different samples because fire spread is always different. After 5 min of temperature calibration, the heat source was ignited and the test has started but t_{sx} represents the reference start time for the evaluation of sample failure. It is useful to mark the value of " t_{sx} " for each sample because it shows required time to exceed the temperature of 200°C on the first level.

The influence of horizontal barriers was observed by comparing the maximum temperature in L2_C that appears in the Sample 1 without horizontal barrier ($T_{\max (t=15:11)} = 526.46^\circ\text{C}$) with the temperature on Sample 2 on the same thermocouple ($T_{(t=15:51)} = 215.6^\circ\text{C}$) which is two times lower. The effect of buoyancy is dependent on the amount of surrounding 'fresh air' entrained through the cav-

zontal barrier and the flame cannot spread easily to the second level at the same moment. The maximum temperature in L2_C of Sample 2 is 308°C but compared to Sample 1 reaching the maximum was delayed for another 10 min. All maximum temperatures were measured on the main wall.

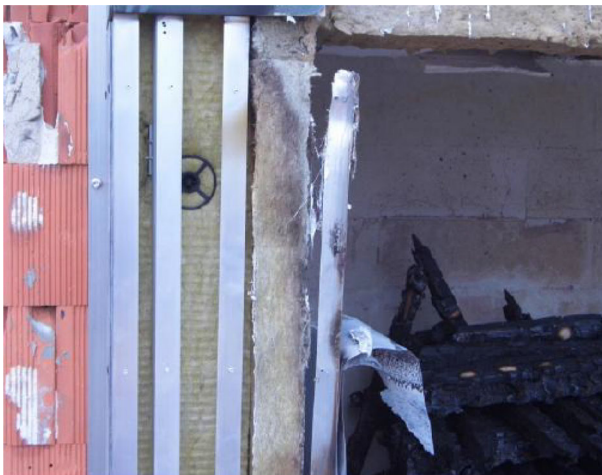
Figure 6. Sample 2- influence of vertical barrier on fire spread.

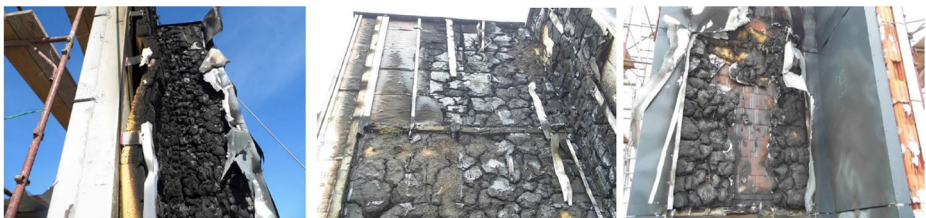
Figure 8. Sample 3,4,5—influence of vertical barrier on fire spread.

The influence of the vertical barrier on the left side of the chamber is visually demonstrable. The combustible insulation on the left side of the vertical barrier that was not protected has lost its properties (Sample 3) and it has partially burned out while ones protected by a vertical barrier (Sample 4 and 5) remained undamaged in both cases Fig. 8.

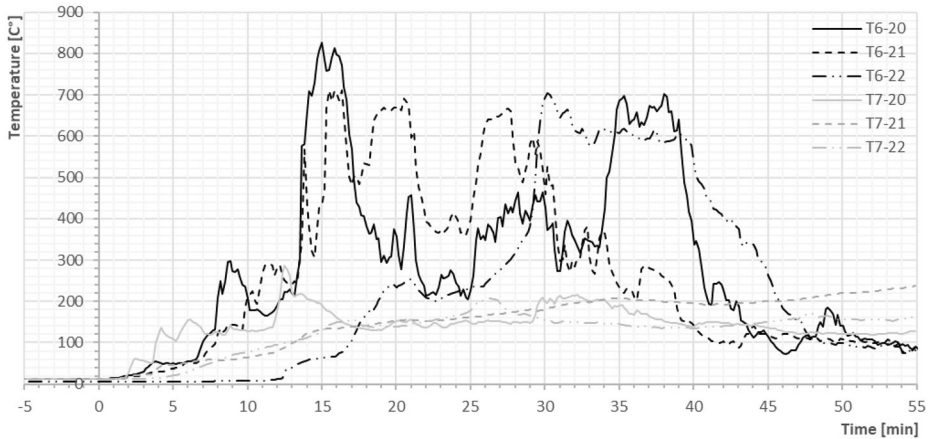
Figure 11. Thermocouple Tn-20-21-22_cavity_Sample 6 and 7.

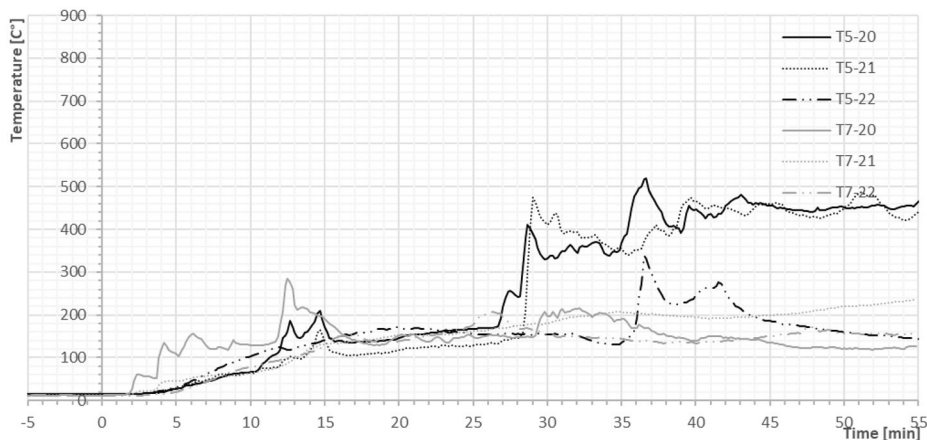
Figure 16. Comparison of temperature distribution around the vertical barrier on the right edge of the chamber -Sample 5 and 7.

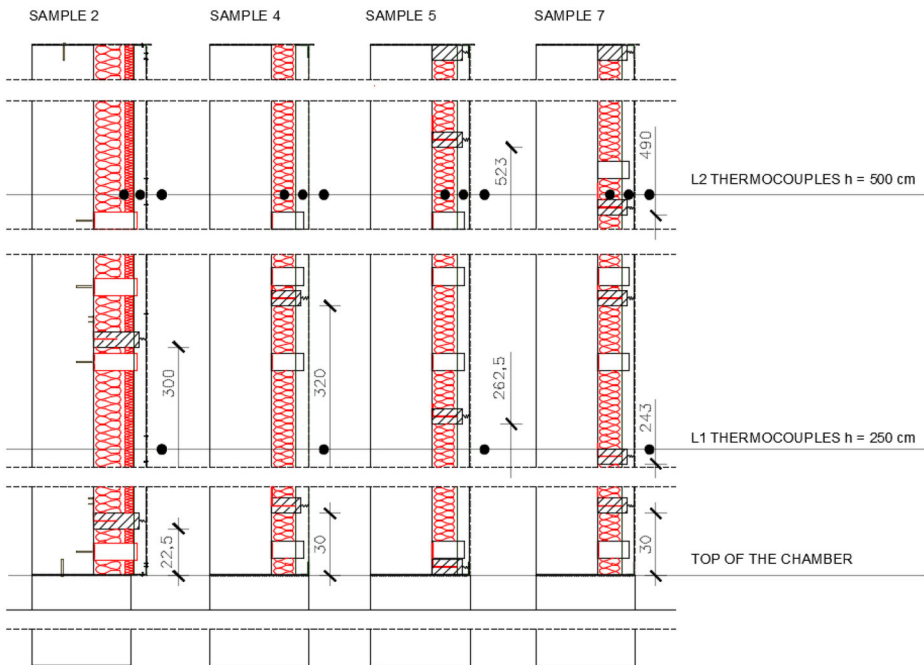
Figure 17. Position of horizontal barriers.

For the horizontal barrier behaviour, it is very important to indicate that the level 2 cavity thermocouples were for Sample 5 located below the 3rd horizontal barrier while for Sample 7 thermocouples were just above the 3rd cavity barrier. In BS 8414-1, the level 2 thermocouple location is specified as 5 000 mm above the combustion chamber, according to the scheme in Fig. 17 in “Appendix”.
