Damage Assessment of Reinforced Concrete Elements Due to Corrosion Effect Using Dynamic Parameters: A Review

Source / Izvornik: **Buildings, 2021, 11(10)**

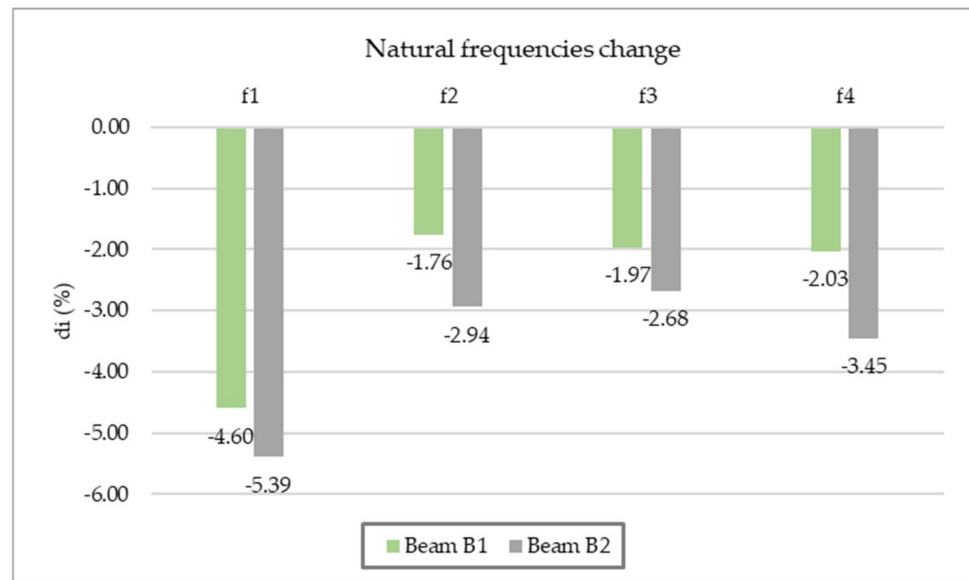
Figure 5. Representation of the change in the values of the natural frequencies for beams B1 (uncorroded) and B2 (corroded) (author's processing based on [46]).

R. Capozucca [50] concluded that the corrosion process did not significantly affect the change of natural frequency and dynamic response of a beam in cases where beams were not exposed to bending loads. Based on this he also concluded that the corrosion process in the absence of cracks in concrete does not significantly affect the dynamic response of the beam. In the case of beams loaded with bending, the decrease in the value of frequencies at certain load stages is greater in beams that have been exposed to artificially induced corrosion, as shown in Figure 5 [50].

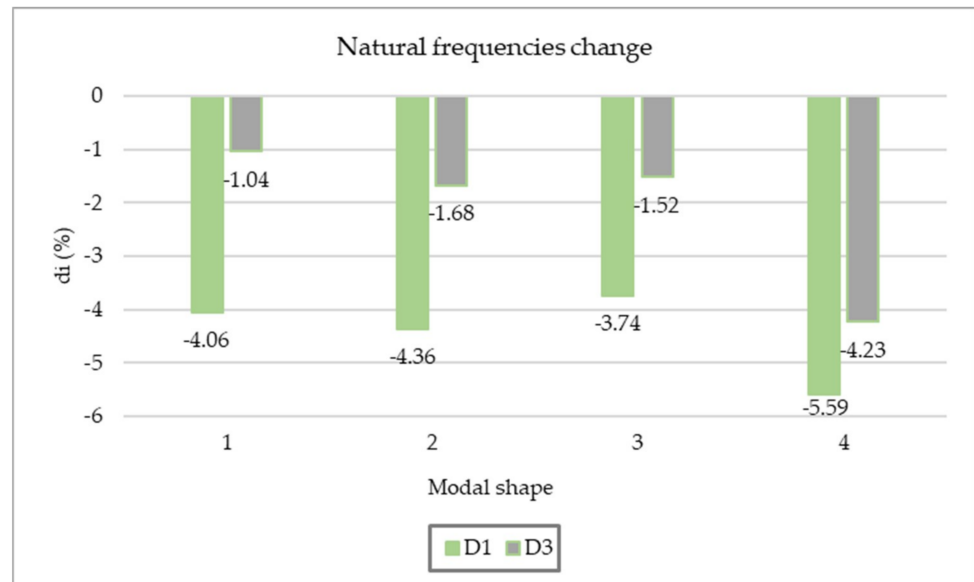
Figure 6. Representation of the change in the values of natural frequencies on beams D1 (steel surface loss 7.77%, maximum crack width 5.0 mm) and D3 (steel surface loss 7.65%, maximum crack width 1.0 mm) (author's processing based on [53]).

H.A. Razak and F.C. Choi [53] concluded that, due to corrosion damage, the D1 beam had a decrease in natural frequencies in the range of 4% to 11%, while the D3 beam had a decrease between 1% and 4% (Figure 6). Also, with the beam D1, a larger decrease in bending stiffness was observed, as well as a smaller bearing capacity than with the beam D3. From the damping coefficients determined for the first three modal forms, their increase was observed in the second and third modal forms, while in the first modal form there was a

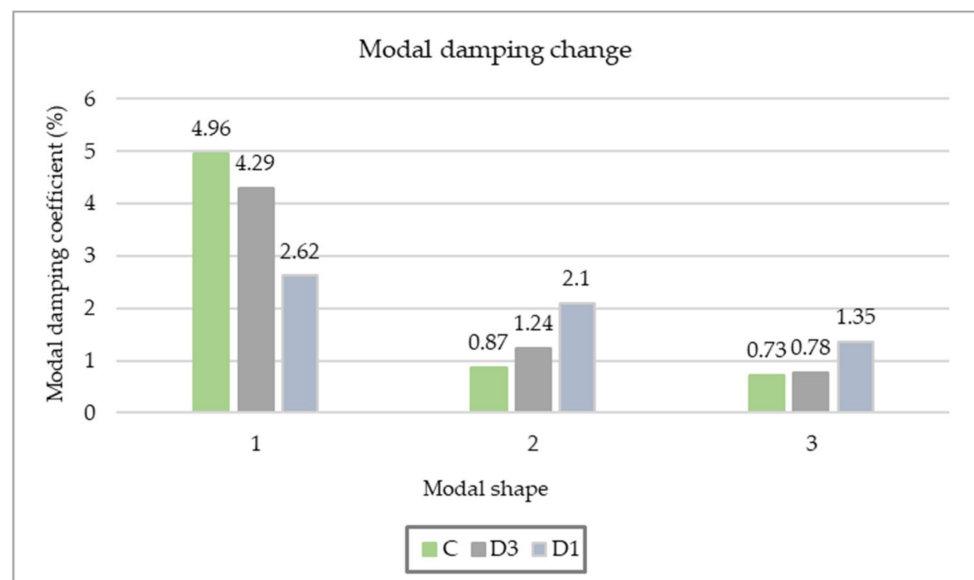
Figure 7. Change of damping coefficient value on beams C (control beam), D1 (steel surface loss 7.77%, maximum crack width 5.0 mm) and D3 (steel surface loss 7.65%, maximum crack width 1.0 mm) (author processing based on [53]).

decrease in the values of damping coefficients; this is explained by a stronger bond between steel and concrete in corroded reinforced concrete elements due to accumulated corrosion products (Figure 7). The above research results show that the decrease in the value of natural frequencies and the decrease in the value of bending stiffness, i.e., the increase in the value of the damping coefficients is greater the more damaged the sample [53].

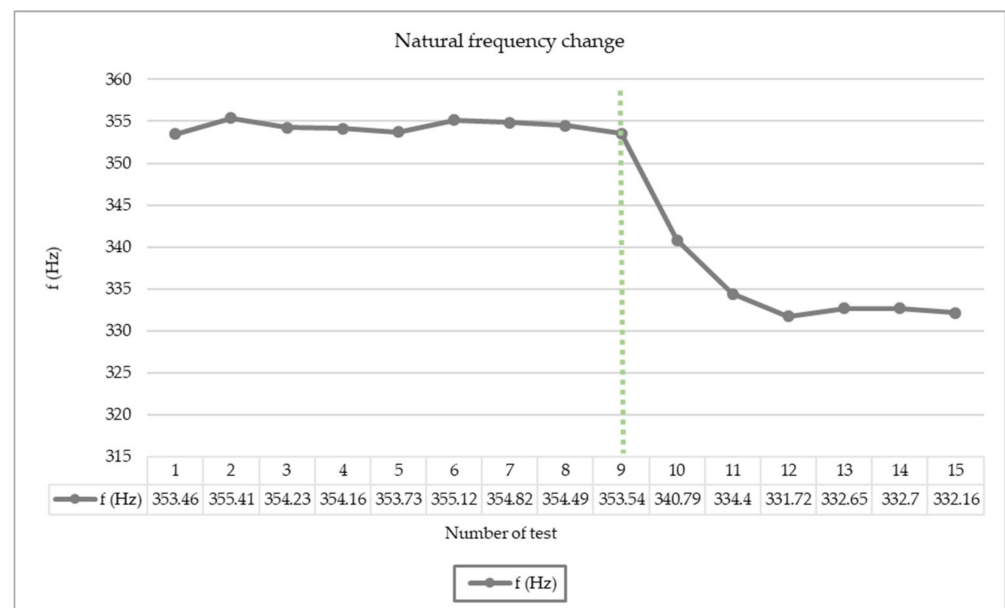
Figure 8. Change in the natural frequency values after a single test (author's processing based on [56]).

By examining the Tr-2 and Tr-3 samples in article [56], the change in the values of the natural frequency and damping coefficients at different degrees of local corrosion was monitored. As part of the Tr-2 sample test, dynamic tests were performed at three different degrees of corrosion (L-1, L-2, and L-3). In the third stage (L-3) there was a decrease in the value of natural frequencies in the amount of 33.17% compared with the undamaged state, while the value of the attenuation coefficient was 7.68 times higher. In the Tr-3 sample, dynamic tests were performed after each of the fifteen accelerated corrosion tests and changes in the values of the natural frequency and damping coefficients were monitored during each test, as was the achieved degree of corrosion. The degree of corrosion in this case is shown as the product of the current strength expressed in milliamperes (mA) and the duration of each corrosion process expressed in seconds (s). The test results show that a significant decrease in the value of the natural frequency, i.e., an increase in the value

of the damping coefficient, occurred after the tenth accelerated corrosion procedure (at a corrosion rate of $9720 \text{ A} \times \text{s}$), which is explained by the appearance of a crack at the bottom of the sample just before the tenth procedure (Figure 8). Dynamic tests after the last series of fifteen procedures showed a decrease in the value of the natural frequency in the amount of 5.8%, and an increase in the value of the damping coefficient in the amount of 117%, demonstrating that changes in the damping value are more sensitive to damage caused by corrosion [56].
