Mechanical and Fire Performance of Innovative Hollow Glue-Laminated Timber Beams

Perković, Nikola; Rajčić, Vlatka

Source / Izvornik: **Polymers, 2022, 14(16)**

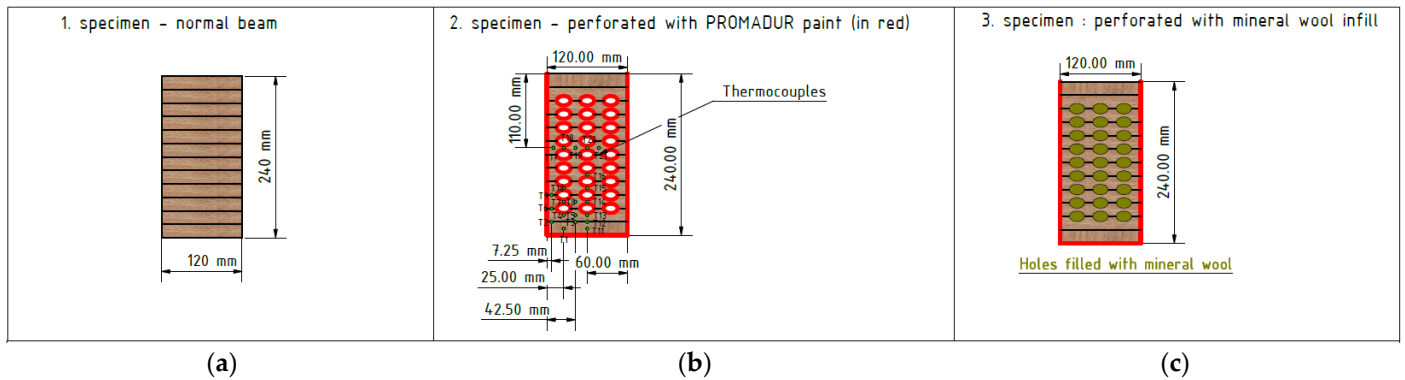
Figure 8. Specimen cross-section: (a) normal beam; (b) hollow with intumescent paint; (c) hollow with mineral wool infill.

The dimensions of the samples were the same as in the mechanical tests, as follows: 120 × 240 × 5040 mm (width × height × length). Moisture was measured in each sample and the average moisture was 10% for all samples. The laminated timber sample consisted of a total of twelve lamellae glued together. The slats were made of soft timber (fir) 20 mm thick and made in such a way that the fibers inside the timber were directed in the direction of the length of the beam (see Figures 8 and 9). The lamellas were glued using Kleiberit 510.0 glue, manufactured by Klebchemie-M.G. Becker GmbH [24]. This is a PUR adhesive for load-bearing wood construction certified in accordance with DIN 1052 [30]. An advantage and difference compared to previous research [23] was that this adhesive has a very high bond strength due to specially reinforced fibers. Three different types of timber beams were tested to compare innovative hollow glue-laminated timber elements with standard and most used timber products. Therefore, the first sample was a standard GL timber beam, and the other two were hollow GL beams with fire protection. In the first hollow beam, the protection was an intumescent paint coating, Promadur [31], along the perimeter of the beam and inside the cavity, while in the second the mineral wool was placed in cavities and intumescent paint was also applied on the outer surface of the sample. In this research, PROMADUR [31] intumescent paint was used. It is a single-pack water-borne, solvent-free transparent intumescent coating for fire protection of timber structures. In the case of fire, PROMADUR expands, creating a protective insulating foam that protects the substrate from contact with air (oxygen), decreasing the combustibility, and slowing down the transfer of energy (heat) from the fire to the timber elements, increasing the fire resistance. The general idea was to use cavities in such a way as to partially stop the penetration of fire and temperature towards the interior of the beam. Figure 8 shows different types of cross-sections of investigated timber beams.

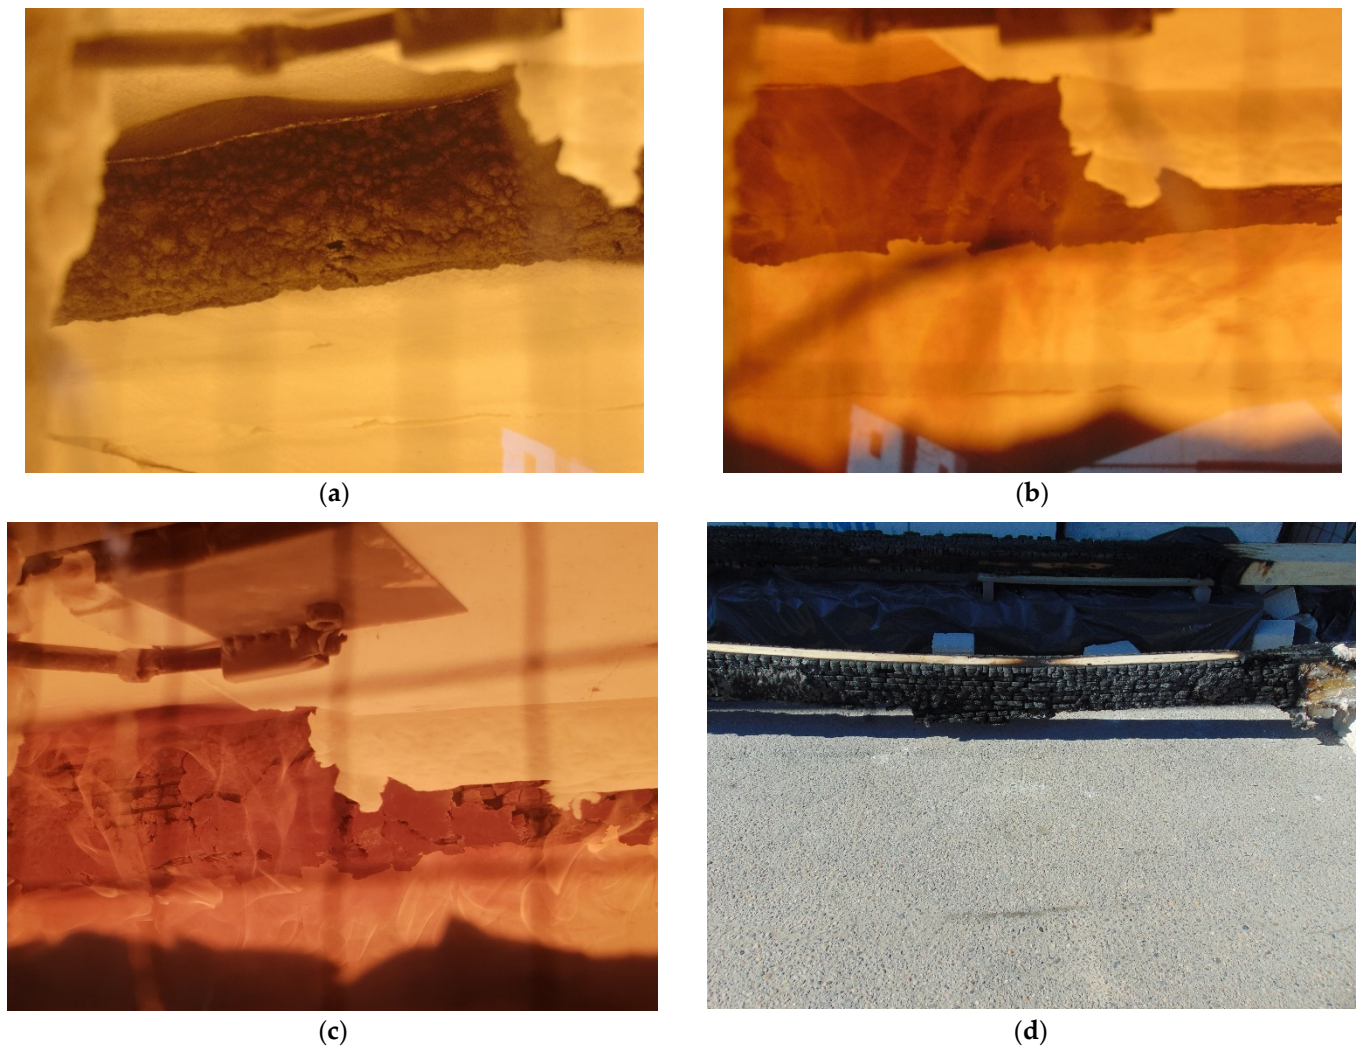
Figure 19. Hollow beam (Mineral wool)—phases of the fire test: (a) 5 min; (b) 20 min; (c) 41 min; (d) the end of the test.

Different phases of hollow (with MW) GL timber beam in the fire tests are shown in Figure 19a–c, while burnt beam at the end of the test can be seen in Figure 19d.
