# Mechanical and Fire Performance of Innovative Hollow Glue-Laminated Timber Beams

*Source / Izvornik:* **Polymers, 2022, 14(16)**

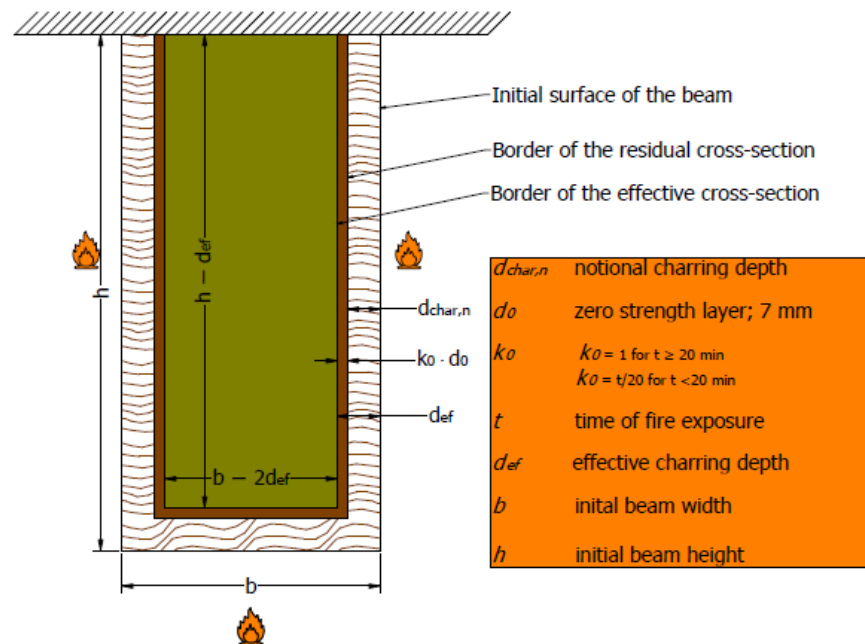
Figure 3. Definition of ideal residual cross-section (EN 1995-1-2, 2004 [25]).

The fire resistance time for a normal GL timber beam can be estimated by defining the ideal residual cross-section (Figure 3) according to EN 1995-1-2 [25], and comparing the actual bending stress, which depends on the residual cross-section values at a given time:

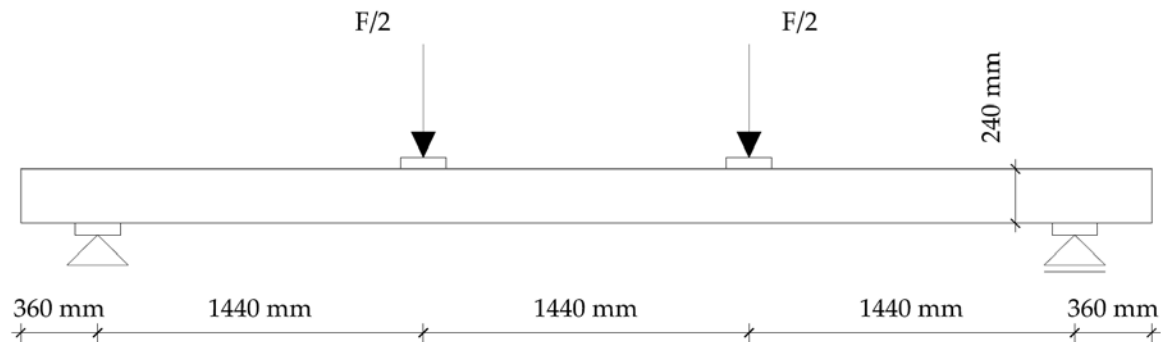
Figure 4. Test setup—4-point bending.

To determine the load level for the fire test, four-point bending tests on timber elements were carried out according to EN 408 [27]. The tests were carried out on a simply supported beam with a span of  $18h$ , where  $h$  is the height of the sample. The distance of the load input from the support and the distance between the forces themselves was  $6h$  (Figure 4). To avoid local stresses, additional steel plates were placed at the point of load application. In this way, the correct load distribution on the sample was obtained.

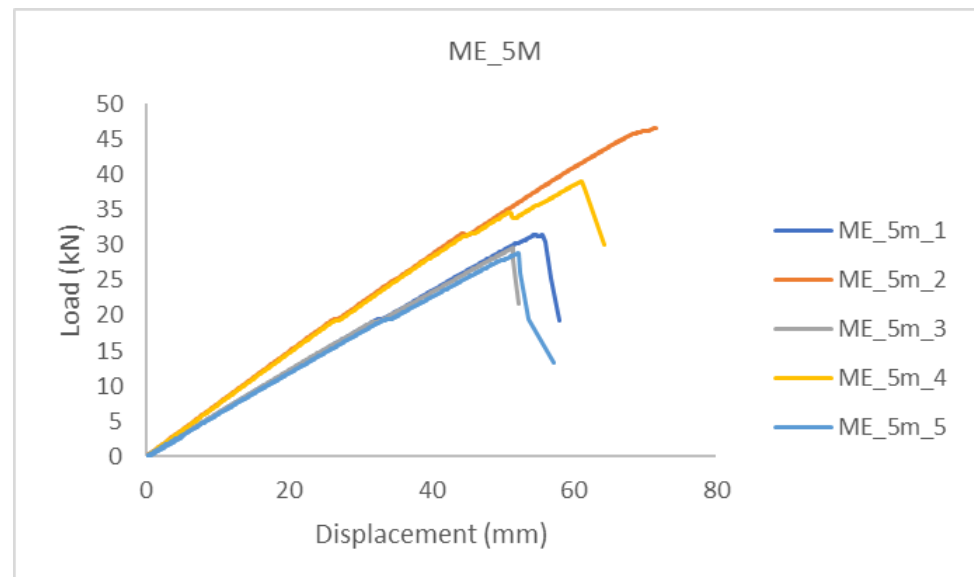
**Figure 7.** Load-displacement—hollow glued laminated samples.

The linear behavior of the elements can be seen in the diagrams, after which a brittle fracture occurred. Furthermore, a minimal force reduction is observed in the diagrams, indicating the cracking of a particular lamella or grain. After that, the force increases again until the fracture of the next grain, and so on, until the complete fracture of the sample occurs when it reaches its tensile strength (Figures 6 and 7).

In Figure 7, it can be seen that the failure of samples with the same type of cavities did not occur at the same load value. The cause was mostly natural wood defects, such as knots, shakes, cross-grain, crookedness, rind galls, burrs, and curls.

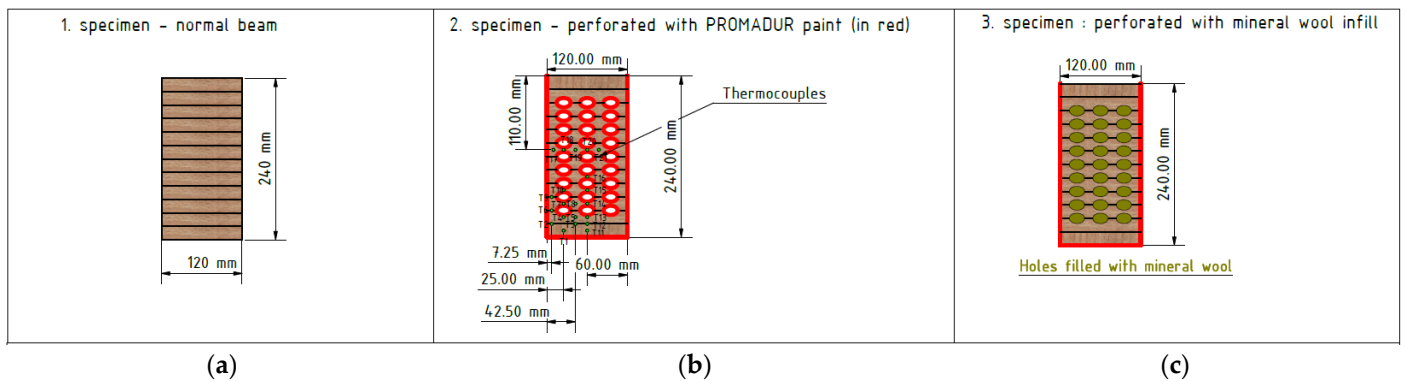
Figure 8. Specimen cross-section: (a) normal beam; (b) hollow with intumescent paint; (c) hollow with mineral wool infill.

The dimensions of the samples were the same as in the mechanical tests, as follows: 120 × 240 × 5040 mm (width × height × length). Moisture was measured in each sample and the average moisture was 10% for all samples. The laminated timber sample consisted of a total of twelve lamellae glued together. The slats were made of soft timber (fir) 20 mm thick and made in such a way that the fibers inside the timber were directed in the direction of the length of the beam (see Figures 8 and 9). The lamellas were glued using Kleiberit 510.0 glue, manufactured by Klebchemie-M.G. Becker GmbH [24]. This is a PUR adhesive for load-bearing wood construction certified in accordance with DIN 1052 [30]. An advantage and difference compared to previous research [23] was that this adhesive has a very high bond strength due to specially reinforced fibers. Three different types of timber beams were tested to compare innovative hollow glue-laminated timber elements with standard and most used timber products. Therefore, the first sample was a standard GL timber beam, and the other two were hollow GL beams with fire protection. In the first hollow beam, the protection was an intumescent paint coating, Promadur [31], along the perimeter of the beam and inside the cavity, while in the second the mineral wool was placed in cavities and intumescent paint was also applied on the outer surface of the sample. In this research, PROMADUR [31] intumescent paint was used. It is a single-pack water-borne, solvent-free transparent intumescent coating for fire protection of timber structures. In the case of fire, PROMADUR expands, creating a protective insulating foam that protects the substrate from contact with air (oxygen), decreasing the combustibility, and slowing down the transfer of energy (heat) from the fire to the timber elements, increasing the fire resistance. The general idea was to use cavities in such a way as to partially stop the penetration of fire and temperature towards the interior of the beam. Figure 8 shows different types of cross-sections of investigated timber beams.

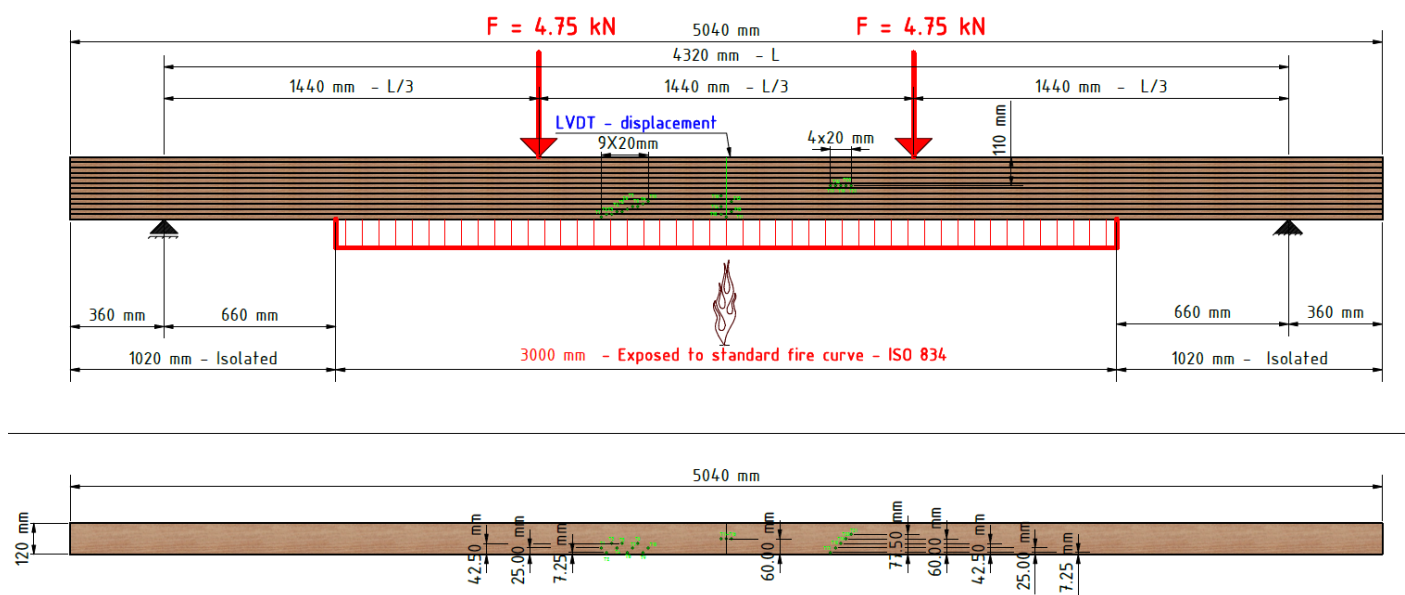
Figure 9. Fire test-experiment setup.

The samples were exposed to fire on three sides (bottom and sides). The load-bearing beam specimen was mounted on a vertical load-bearing structure equipped with a hydraulic system for applying the load. The load-bearing structure was placed on the horizontal test furnace in such a way that only a part of the beam 3000 mm long was exposed to fire. The beam was oriented so that the longer side of the section (240 mm) was placed vertically. The beam supports were located outside the test furnace at a distance of 4320 mm from each other. On one side of the beam, one support was fixed, and on the other side, it was sliding in the longitudinal direction. All the above described can be seen in Figure 9.

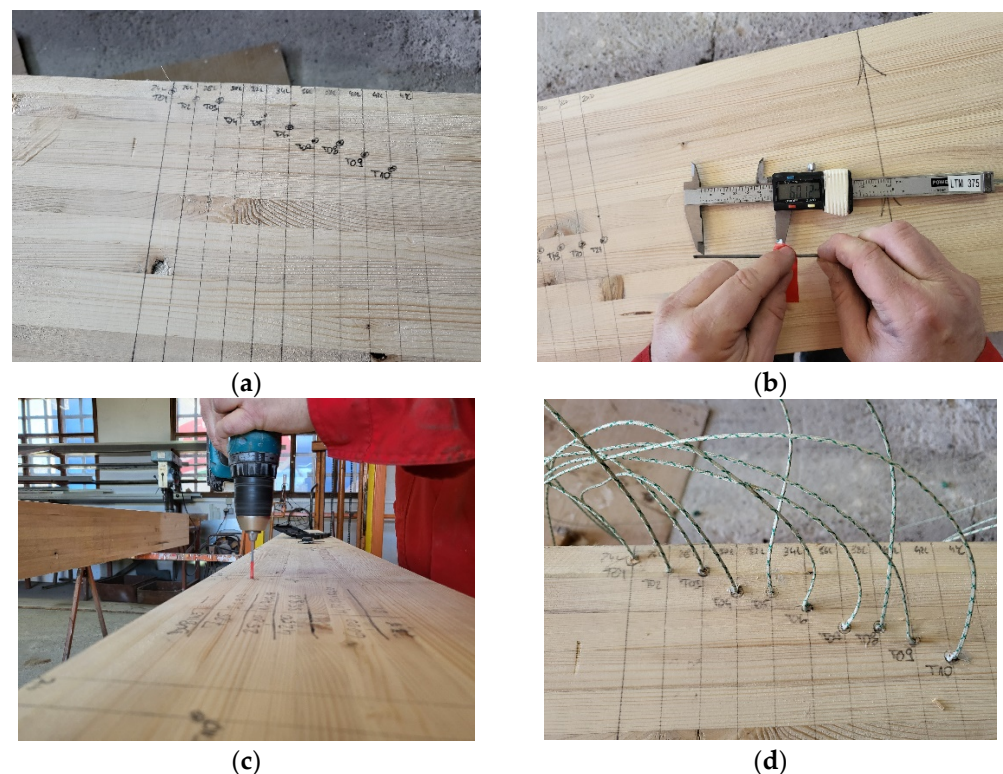
**Figure 11.** Thermocouple installation process: (a) marking the beam; (b) measuring and marking the drill; (c) hole drilling; (d) installation of the thermocouples.

Temperatures through the sample cross-section were measured with 21 NiCr-Ni thermocouples, (type K) wire  $\varnothing 0.5$  mm. The installation process of thermocouples can be seen in Figure 11. After insertion, the thermocouples were additionally fixed with wooden wedges, while the holes were filled with fireproof silicone. In this way, the position and depth of the thermocouples were fully ensured.

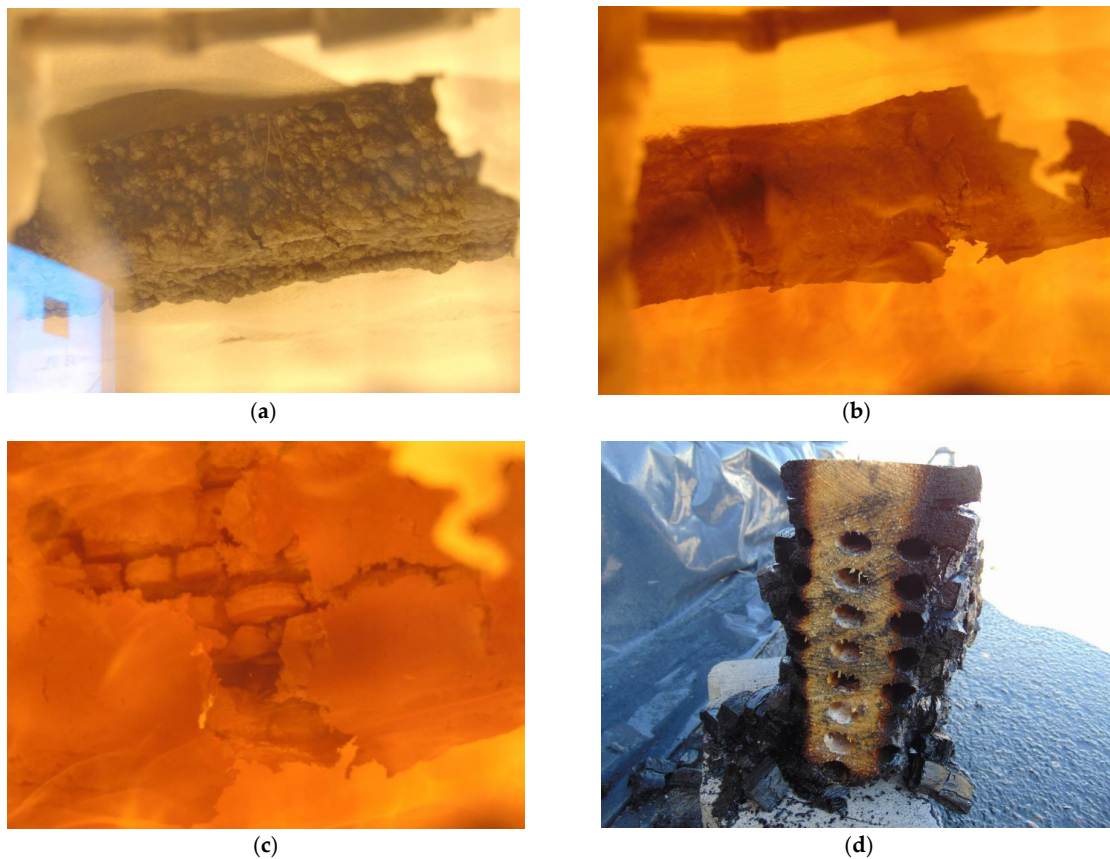
Figure 17. Hollow beam (Promadur)—phases of the fire test: (a) 5 min; (b) 20 min; (c) 41 min; (d) the end of the test.

Different phases of hollow (Promadur) GL timber beam in the fire tests are shown in Figure 17a–c, while burnt beam at the end of the test can be seen in Figure 17d.

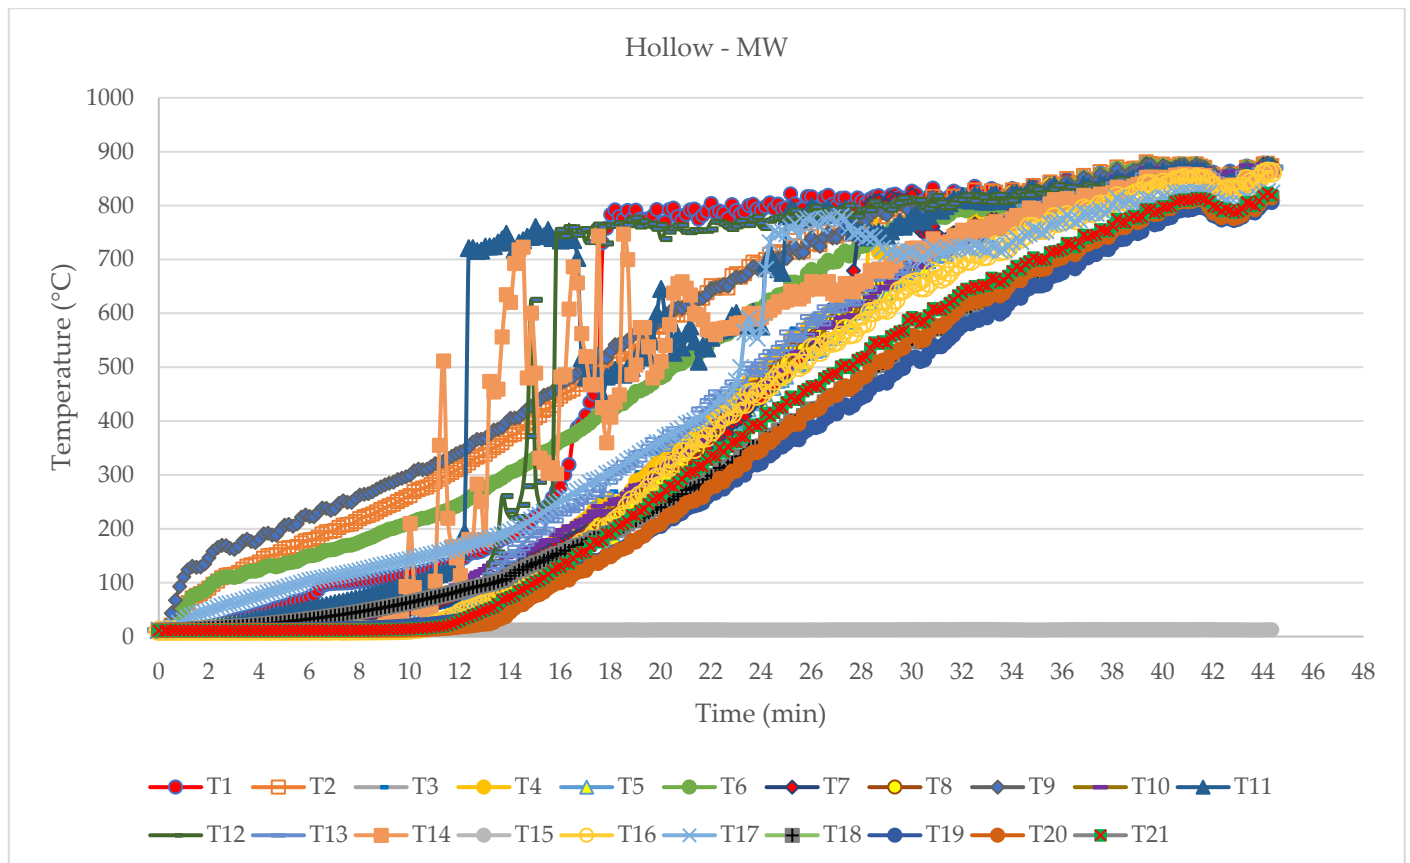
Figure 18. Temperature development diagram—hollow MW.

The sample with mineral wool infill behaved very similarly to the previous sample. The reason for this was that both samples had intumescent paint on the outside surface, and the difference was manifested in the fact that the mineral wool quickly fell off the sample and the fire reached the unexposed part of the timber sooner. This can also be seen in Figure 18, where we see more “lost” thermocouples that have fallen off the sample. The main observations during the fire test can be seen in Table 7.

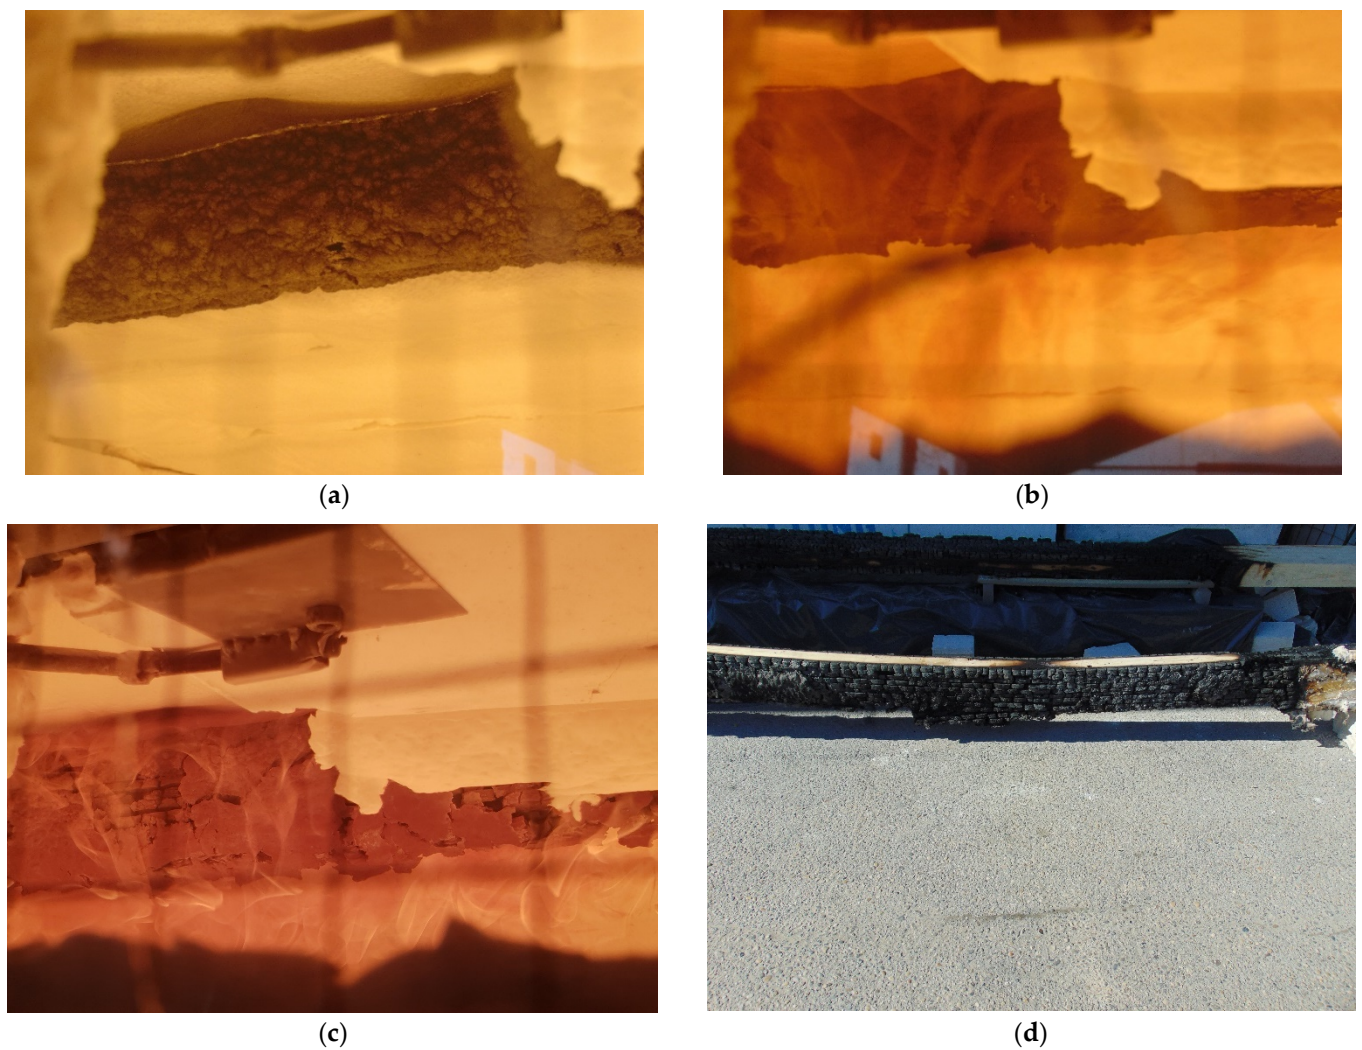
**Figure 19.** Hollow beam (Mineral wool)—phases of the fire test: (a) 5 min; (b) 20 min; (c) 41 min; (d) the end of the test.

Different phases of hollow (with MW) GL timber beam in the fire tests are shown in Figure 19a–c, while burnt beam at the end of the test can be seen in Figure 19d.
