# Assessment of Existing Masonry Resistance Using Partial Factors Approaches and Field Measurements

Source / Izvornik: **Buildings**, 2023, 13, 1 - 16

## Article

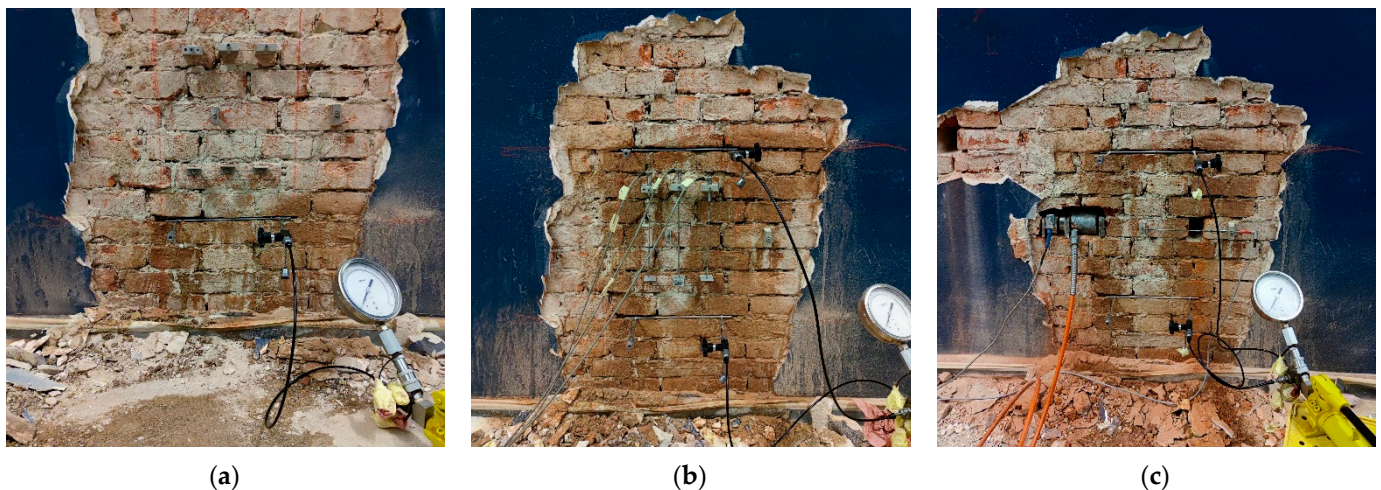
Given that the mechanical properties of existing masonry structures can vary greatly, it is very useful to determine the actual values of these properties through in situ testing [52]. As part of the investigative work, flat-jack tests were performed on three original load-bearing walls from the same construction period that have a similar thickness. The locations of the tests are marked with red triangles in Figure 2b. All phases of the test itself are shown in Figure 3.

**Figure 3.** Flat-jack test setup for determining (a) vertical stress state, (b) modulus of elasticity and (c) shear strength.

Using only conservative values of the material mechanical properties, without in situ tests, can result in a significant overestimation or underestimation of the structural capacity. In situ, semi-destructive methods such as flat-jack can significantly contribute to the quality of the assessment procedure. It provides values for the state of vertical stress, modulus of elasticity and shear strength of the masonry. The flat-jack test is not the main focus of this paper and, therefore, will not be explained in detail. For more specific information about the test itself and its application, see [53,54].
