Assessment of Existing Masonry Resistance Using Partial Factors Approaches and Field Measurements

Source / Izvornik: **Buildings**, 2023, 13, 1 - 16

Keywords: masonry; existing structures; earthquake; assessment; DVM; APFM

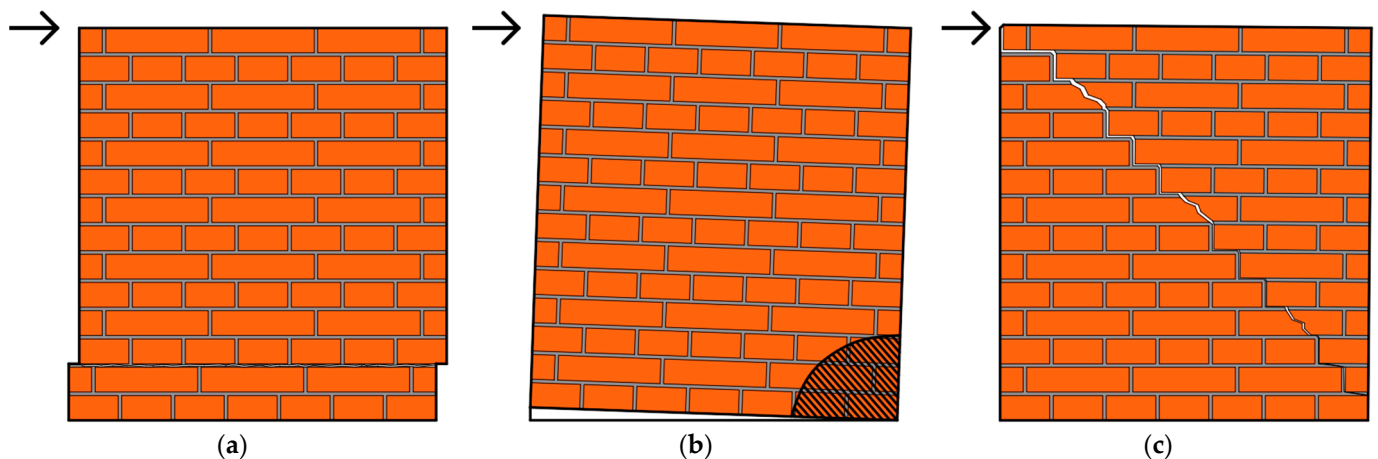
Figure 1. Masonry failure modes (a) shear sliding, (b) bending and (c) diagonal failure.

There are three basic failure modes for masonry (Figure 1). These are shear sliding (Equations (7)–(9)), bending (Equations (10)–(14)) and diagonal failure (which further can be divided into flat (Equations (15)–(16)) and stepped diagonal failure (Equation (17)).

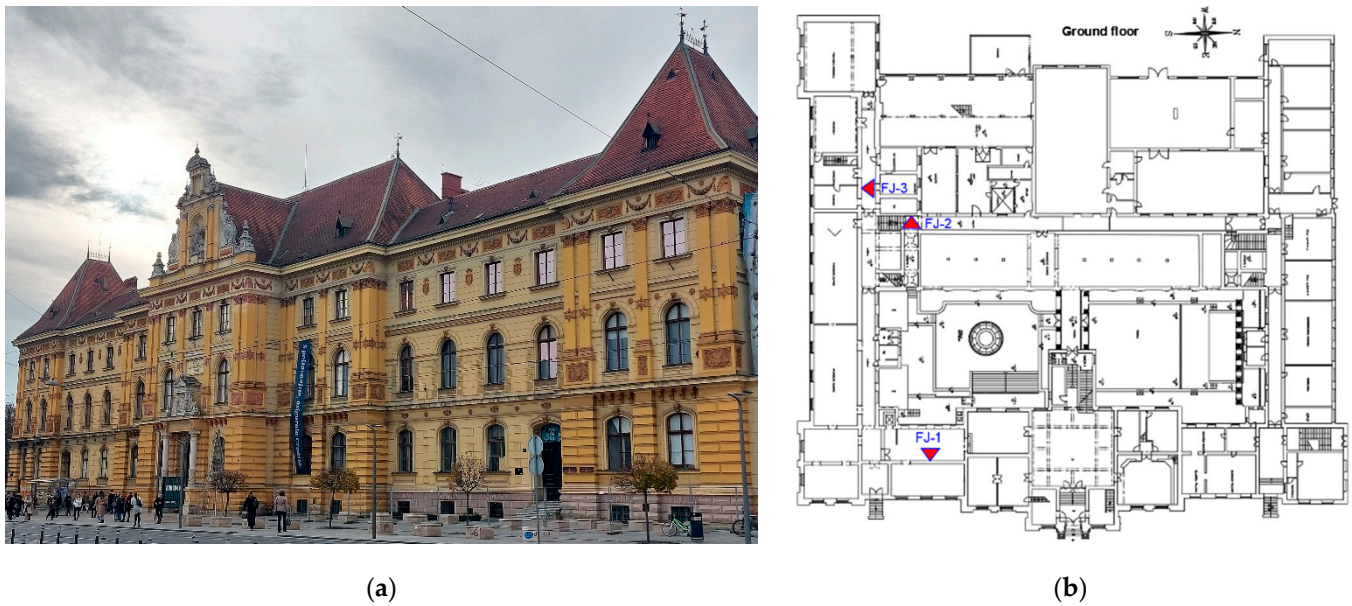
Figure 2. Case study building (a) east facade and (b) ground floor plan.

The selected case study building is located in one of the most impressive squares in the historical center of Zagreb. The building has a cultural and artistic purpose, as it houses a museum of arts and crafts. Usually the host of various highly attended cultural events, the building is currently closed due to damage caused by recent earthquakes. The building was built in 1888 in the spirit of the German Renaissance and has a basement, ground floor, two floors and attic. The main load-bearing structure is URM (50–60 cm thick walls) with low-stiffness floor structures (masonry vaults in the basement and timber beams on other floors). The roof structure is also made of timber. The east facade and ground floor plan of the building are shown in Figure 2a,b.

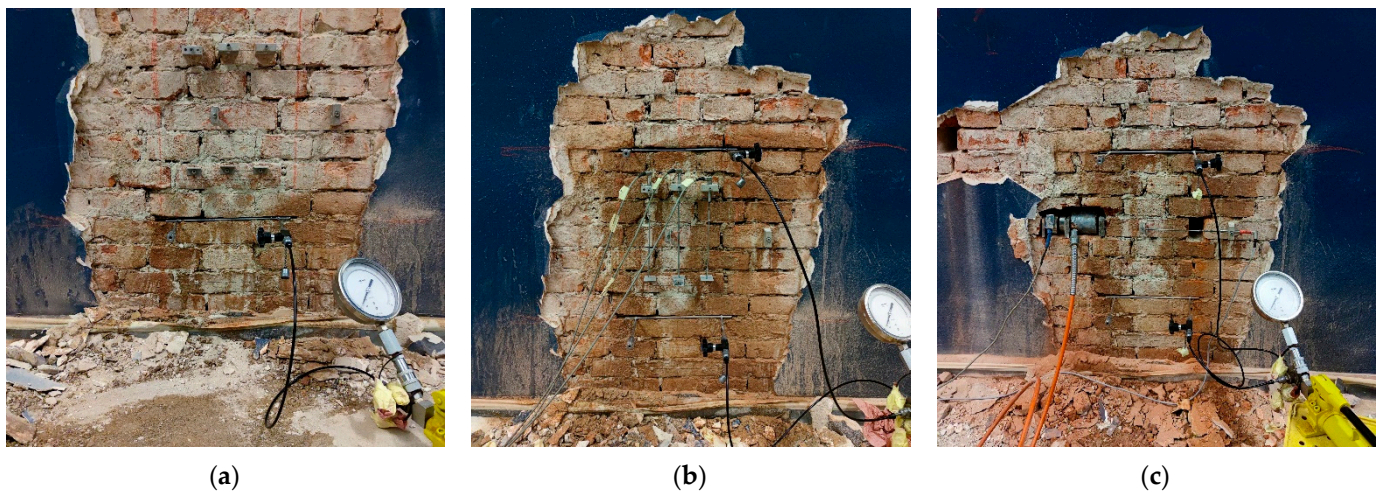
Figure 3. Flat-jack test setup for determining (a) vertical stress state, (b) modulus of elasticity and (c) shear strength.

Given that the mechanical properties of existing masonry structures can vary greatly, it is very useful to determine the actual values of these properties through in situ testing [52]. As part of the investigative work, flat-jack tests were performed on three original load-bearing walls from the same construction period that have a similar thickness. The locations of the tests are marked with red triangles in Figure 2b. All phases of the test itself are shown in Figure 3.

Using only conservative values of the material mechanical properties, without in situ tests, can result in a significant overestimation or underestimation of the structural capacity. In situ, semi-destructive methods such as flat-jack can significantly contribute to the quality of the assessment procedure. It provides values for the state of vertical stress, modulus of elasticity and shear strength of the masonry. The flat-jack test is not the main focus of this paper and, therefore, will not be explained in detail. For more specific information about the test itself and its application, see [53,54].

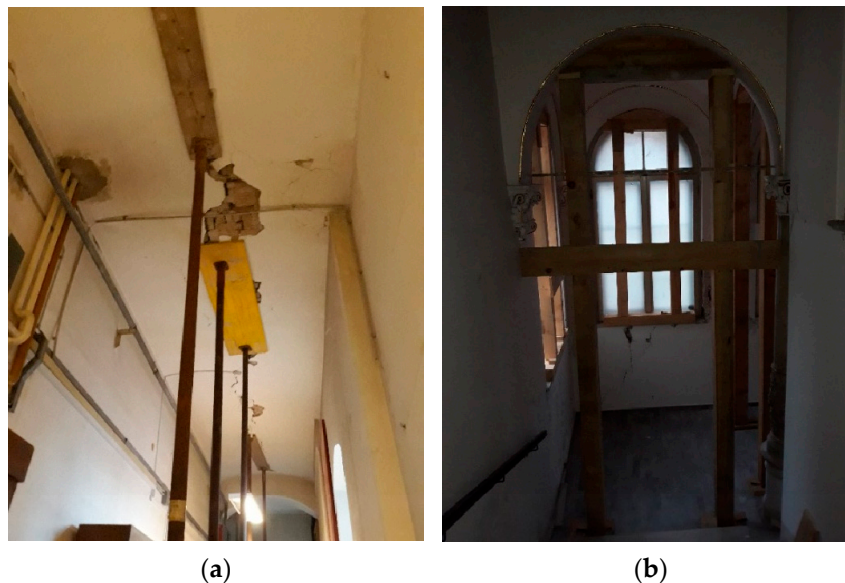
Figure 4. Emergency interventions taken to ensure the stability of (a) damaged vaults and (b) staircases.

strengthen the structure to current standards. With this in mind, emergency measures are taken throughout the building to ensure the safety of workers as well as the stability of the damaged vaults and staircases. The application of the mentioned measures can be seen in Figure 4.

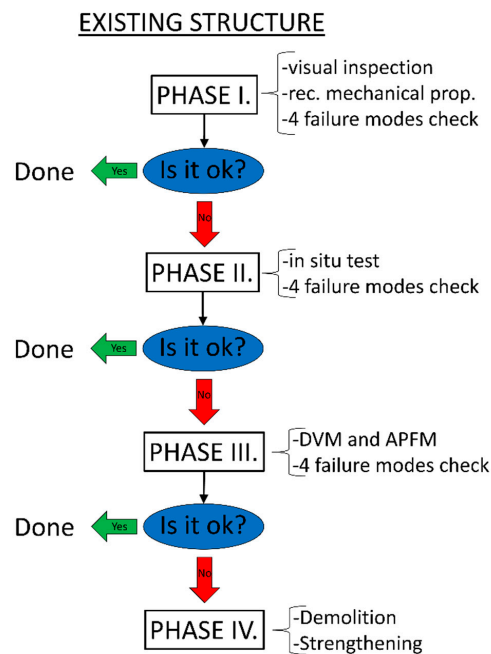
Figure 5. Assessment phases.

The verification of the selected masonry wall is carried out in three phases. The schematic representation of phases shown in Figure 5 is an adaptation according to [47]. The dominant mode of failure, that is, the mode with the least resistance is most often diagonal failure, but all four failure modes should be checked for every wall because the typology of the wall, the boundary conditions and the distribution of internal forces can affect the dominant failure mode.

Initially, data combining recommendations from standards and assumptions are used (phase 1). Then, the data obtained by flat-jack testing are used to update previously used data (phase 2). And finally, DVM and APFM analysis is conducted (phase 3). Phases 1 and 2 are conducted through a semi-probabilistic approach defined in Eurocode.

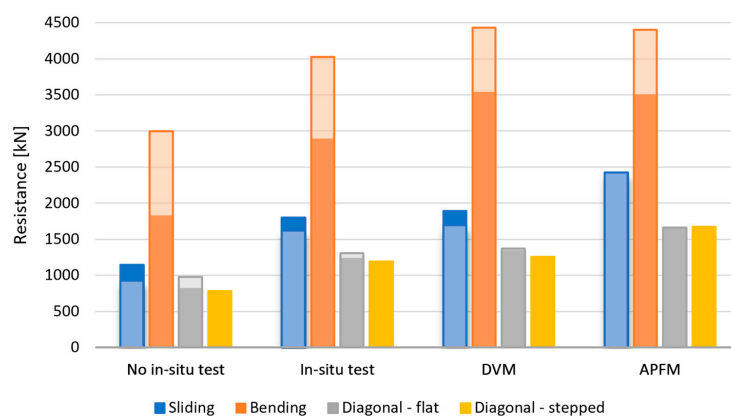
Figure 6. Results for URM wall resistance according to the current EN 1998-3 and the new proposal for EN 1998-3.

For a more complete understanding, Figure 6 graphically represents the obtained results. It shows a clear trend for all failure modes, with resistance increasing as a function

of the complexity of the method used. The colors of the columns represent the failure modes, while the intensity of these colors represents the version of the standard used. A lighter color is used for the current EN 1998-3, while a darker color is used for the new proposal of EN 1998-3. The yellow indicates an additional failure mode, diagonal stepped failure, that is not in the current standards. It is similar to diagonal flat failure and produces similar results, but diagonal stepped failure is slightly more dominant. Diagonal straight cracks characterize diagonal flat failure, which is typical for irregular masonry. It can also occur in regular masonry if the masonry units have low strength compared to the mortar strength. Diagonal stepped failure is characterized by a diagonal stepped crack propagating through the mortar joints and is more typical of regular masonry. Diagonal flat failure is predominant in all cases considered for the current EN 1998-3, except for the case where there are no in situ tests. This can be explained by the fact that the initially assumed values differ from the measured ones. However, diagonal stepped failure predominates in three of four cases for the new EN 1998-3 proposal. For this reason, the incorporation of the diagonal stepped failure mode in the new version of the Eurocode standard is certainly positive. Also, the observed change in the dominant failure mode by phases emphasizes the importance of checking all four failure modes in order not to overestimate the resistance.

The differences in the results (difference between max and min value divided by the minimum value) for the existing EN 1998-3 amount to 161% for the sliding failure, 48% for the bending failure and 70% for the diagonal flat failure. On the other hand, the differences in the results for the new proposal of EN 1998-3 are 112% for the sliding failure, 95% for the bending failure, 105% for the diagonal flat failure and 114% for diagonal stepped failure.
