Assessment of Existing Masonry Resistance Using Partial Factors Approaches and Field Measurements

Source / Izvornik: **Buildings**, 2023, 13, 1 - 16

Keywords: masonry; existing structures; earthquake; assessment; DVM; APFM

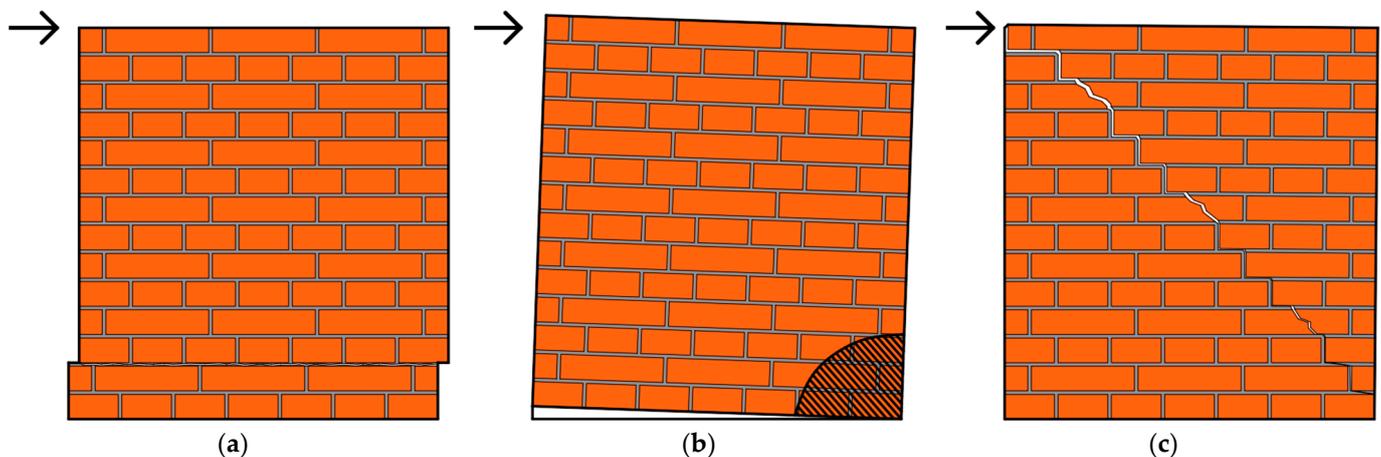
Figure 1. Masonry failure modes (a) shear sliding, (b) bending and (c) diagonal failure.

There are three basic failure modes for masonry (Figure 1). These are shear sliding (Equations (7)–(9)), bending (Equations (10)–(14)) and diagonal failure (which further can be divided into flat (Equations (15)–(16)) and stepped diagonal failure (Equation (17)).

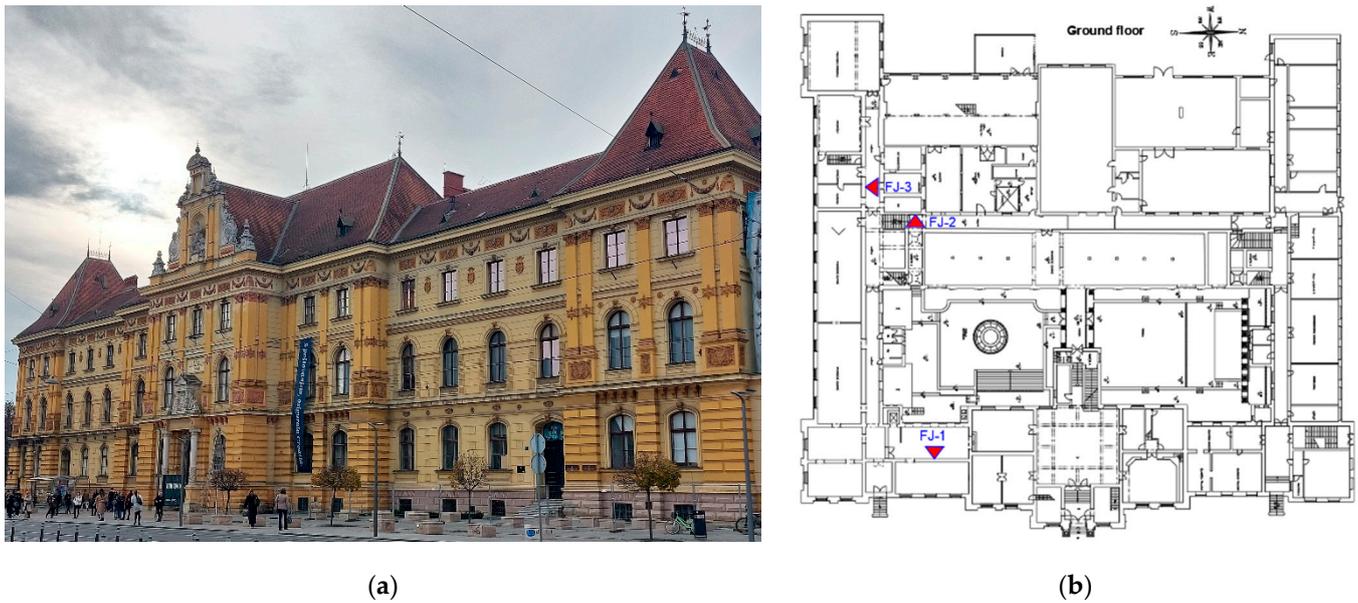
Figure 2. Case study building (a) east facade and (b) ground floor plan.

The selected case study building is located in one of the most impressive squares in the historical center of Zagreb. The building has a cultural and artistic purpose, as it houses a museum of arts and crafts. Usually the host of various highly attended cultural events, the building is currently closed due to damage caused by recent earthquakes. The building was built in 1888 in the spirit of the German Renaissance and has a basement, ground floor, two floors and attic. The main load-bearing structure is URM (50–60 cm thick walls) with low-stiffness floor structures (masonry vaults in the basement and timber beams on other floors). The roof structure is also made of timber. The east facade and ground floor plan of the building are shown in Figure 2a,b.

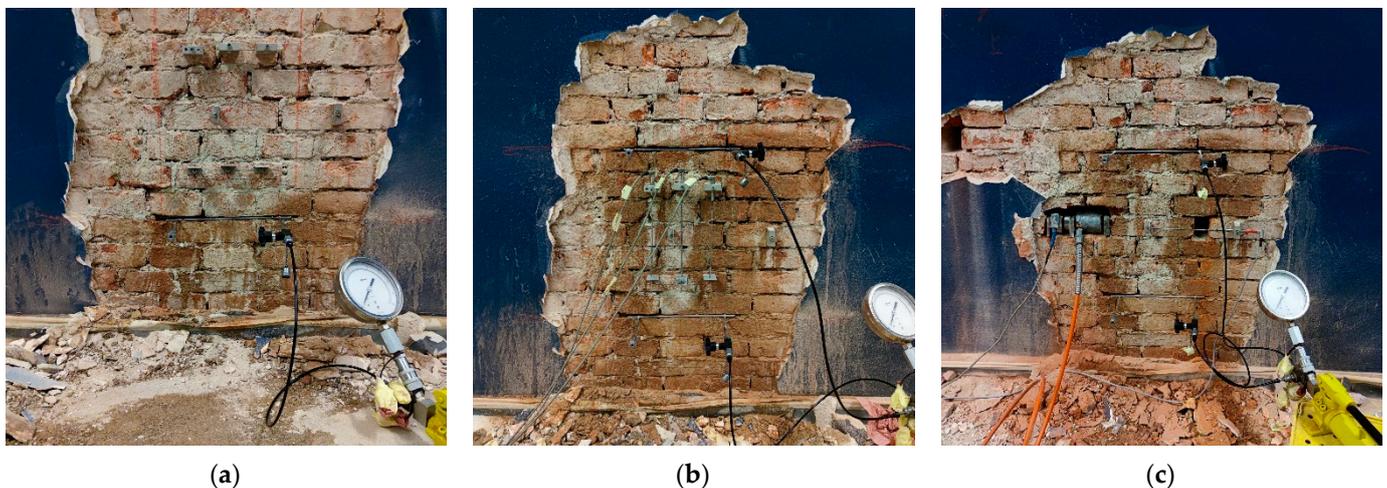
Figure 3. Flat-jack test setup for determining (a) vertical stress state, (b) modulus of elasticity and (c) shear strength.

Given that the mechanical properties of existing masonry structures can vary greatly, it is very useful to determine the actual values of these properties through in situ testing [52]. As part of the investigative work, flat-jack tests were performed on three original load-bearing walls from the same construction period that have a similar thickness. The locations of the tests are marked with red triangles in Figure 2b. All phases of the test itself are shown in Figure 3.

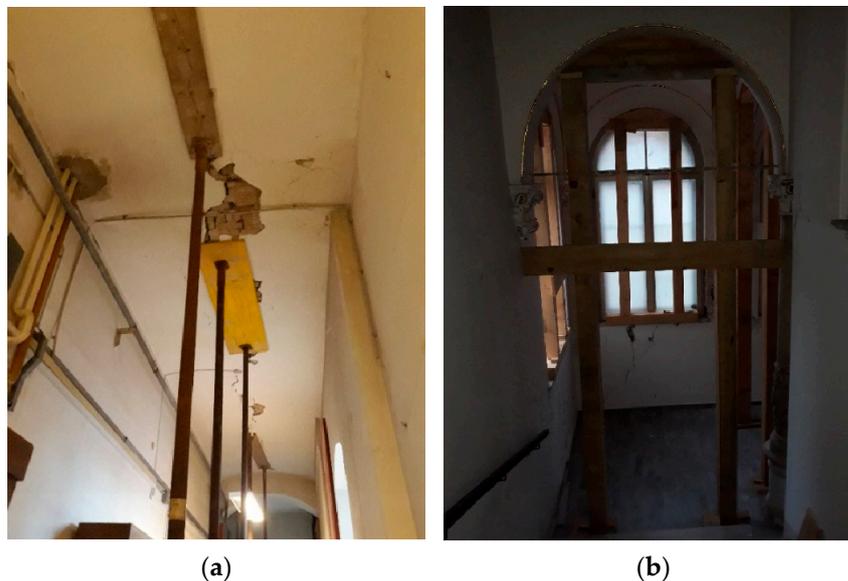
Figure 4. Emergency interventions taken to ensure the stability of (a) damaged vaults and (b) staircases.

strengthen the structure to current standards. With this in mind, emergency measures are taken throughout the building to ensure the safety of workers as well as the stability of the damaged vaults and staircases. The application of the mentioned measures can be seen in Figure 4.

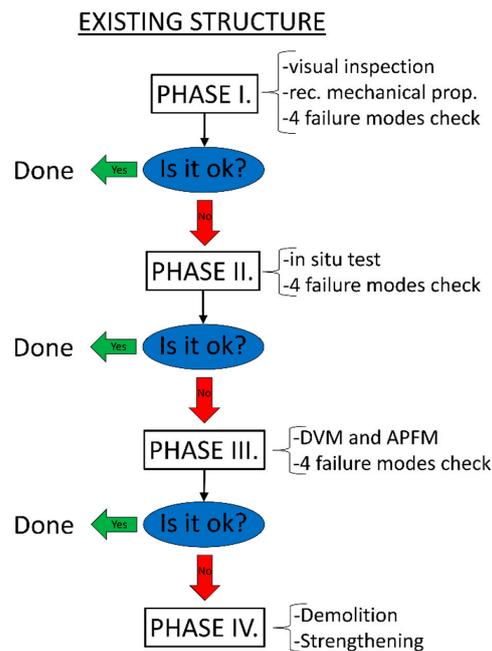
Figure 5. Assessment phases.

The verification of the selected masonry wall is carried out in three phases. The schematic representation of phases shown in Figure 5 is an adaptation according to [47]. The dominant mode of failure, that is, the mode with the least resistance is most often diagonal failure, but all four failure modes should be checked for every wall because the typology of the wall, the boundary conditions and the distribution of internal forces can affect the dominant failure mode.

Initially, data combining recommendations from standards and assumptions are used (phase 1). Then, the data obtained by flat-jack testing are used to update previously used data (phase 2). And finally, DVM and APFM analysis is conducted (phase 3). Phases 1 and 2 are conducted through a semi-probabilistic approach defined in Eurocode.

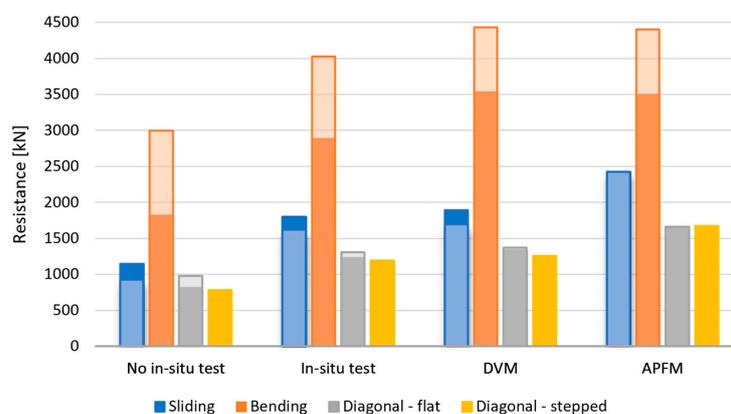
Figure 6. Results for URM wall resistance according to the current EN 1998-3 and the new proposal for EN 1998-3.

For a more complete understanding, Figure 6 graphically represents the obtained results. It shows a clear trend for all failure modes, with resistance increasing as a function

of the complexity of the method used. The colors of the columns represent the failure modes, while the intensity of these colors represents the version of the standard used. A lighter color is used for the current EN 1998-3, while a darker color is used for the new proposal of EN 1998-3. The yellow indicates an additional failure mode, diagonal stepped failure, that is not in the current standards. It is similar to diagonal flat failure and produces similar results, but diagonal stepped failure is slightly more dominant. Diagonal straight cracks characterize diagonal flat failure, which is typical for irregular masonry. It can also occur in regular masonry if the masonry units have low strength compared to the mortar strength. Diagonal stepped failure is characterized by a diagonal stepped crack propagating through the mortar joints and is more typical of regular masonry. Diagonal flat failure is predominant in all cases considered for the current EN 1998-3, except for the case where there are no in situ tests. This can be explained by the fact that the initially assumed values differ from the measured ones. However, diagonal stepped failure predominates in three of four cases for the new EN 1998-3 proposal. For this reason, the incorporation of the diagonal stepped failure mode in the new version of the Eurocode standard is certainly positive. Also, the observed change in the dominant failure mode by phases emphasizes the importance of checking all four failure modes in order not to overestimate the resistance.

The differences in the results (difference between max and min value divided by the minimum value) for the existing EN 1998-3 amount to 161% for the sliding failure, 48% for the bending failure and 70% for the diagonal flat failure. On the other hand, the differences in the results for the new proposal of EN 1998-3 are 112% for the sliding failure, 95% for the bending failure, 105% for the diagonal flat failure and 114% for diagonal stepped failure.
