Assessment of Existing Masonry Resistance Using Partial Factors Approaches and Field Measurements

Source / Izvornik: **Buildings**, 2023, 13, 1 - 16

Article

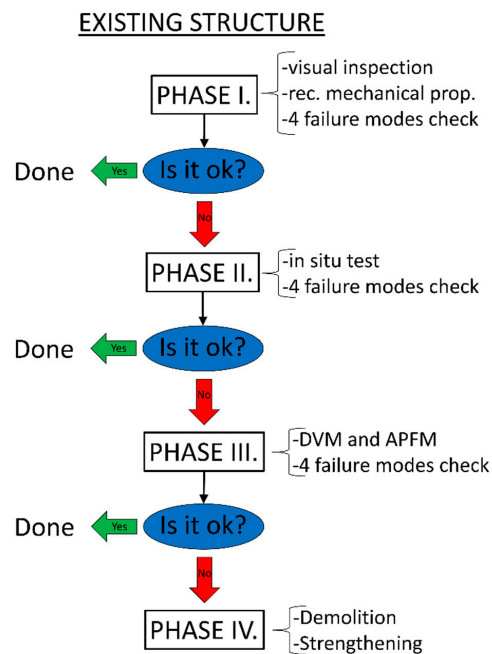
Figure 5. Assessment phases.

The verification of the selected masonry wall is carried out in three phases. The schematic representation of phases shown in Figure 5 is an adaptation according to [47]. The dominant mode of failure, that is, the mode with the least resistance is most often diagonal failure, but all four failure modes should be checked for every wall because the typology of the wall, the boundary conditions and the distribution of internal forces can affect the dominant failure mode.

Initially, data combining recommendations from standards and assumptions are used (phase 1). Then, the data obtained by flat-jack testing are used to update previously used data (phase 2). And finally, DVM and APFM analysis is conducted (phase 3). Phases 1 and 2 are conducted through a semi-probabilistic approach defined in Eurocode.
